TIER-1 PRO INSPECTIONS

COMMERCIAL PROPERTY CONDITION ASSESSMENT

1234 Main Street
Winter Springs, FL 32708

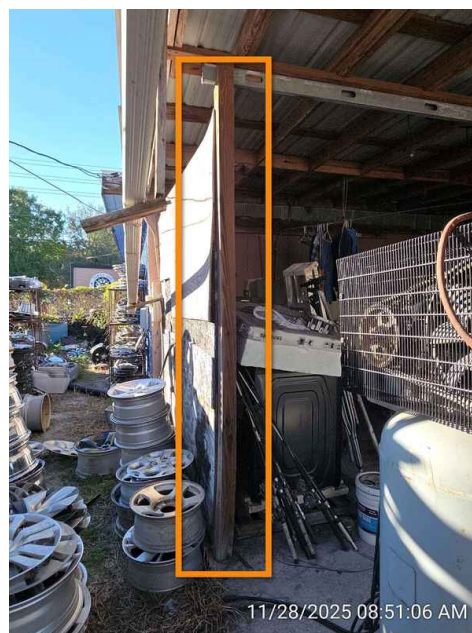
The framing member for the porch roof that attached to the fascia was not secured properly. Evaluation of this roof with repairs made as needed is recommended by a qualified person.

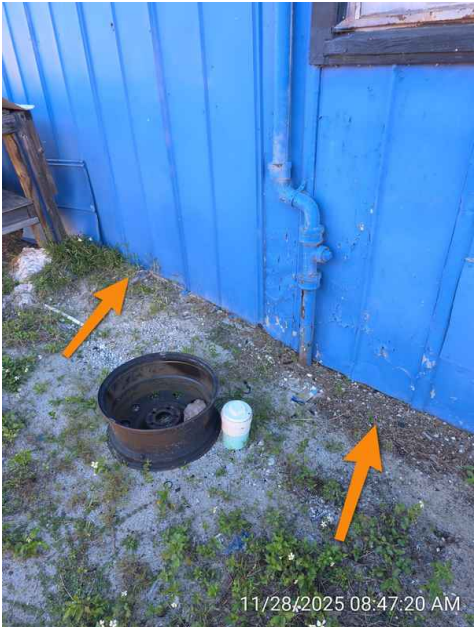
Wall framing members (studs, sole plate, and/or wall sheathing) appeared to be within 6" of finished grade. Current standards require six inches of clearance between grade and wall framing members if preservative treated wood is not used within this 6" space. This inadequate clearance can allow for moisture related damage to the wall framing. Evaluation is recommended by a qualified contractor to determine if preservative treated wood was used, with repairs made as deemed necessary, if necessary.

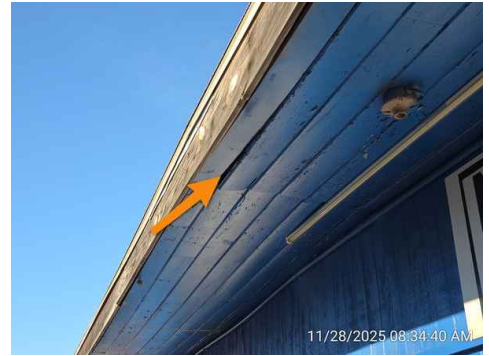
An area of damaged soffit was present. Replacement of the piece(s) is recommended to be performed by a siding contractor or other qualified person to prevent the entry of wildlife or insects into the attic area.

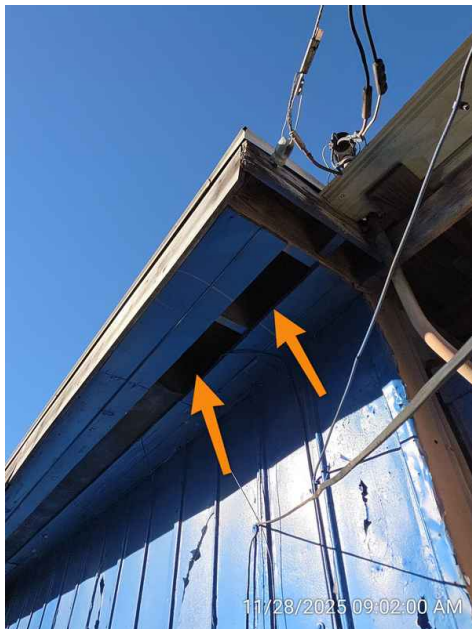
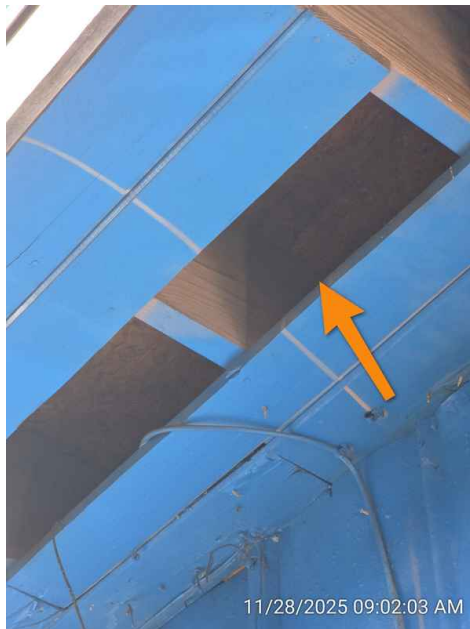
Soffit was missing at the referenced area(s). Replacement of any missing soffit is recommended to be performed by a qualified professional.

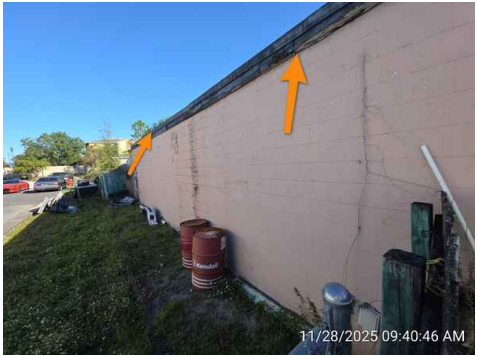
Damaged fascia was observed in the referenced area(s), including visible deterioration and possible water exposure. This condition may allow further moisture intrusion, pest entry, or compromise the attachment of gutters and roofing materials. Recommend evaluation and repairs by a licensed roofing contractor.

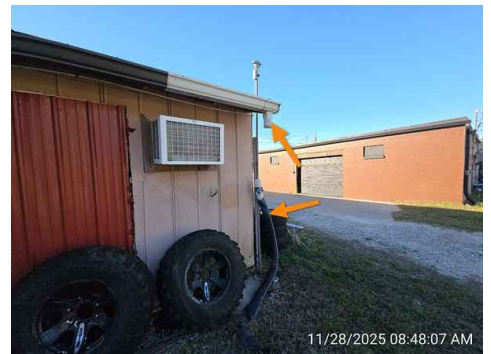
Damaged downspout(s) were present. Replacement or repairs as needed is recommended by a qualified person.

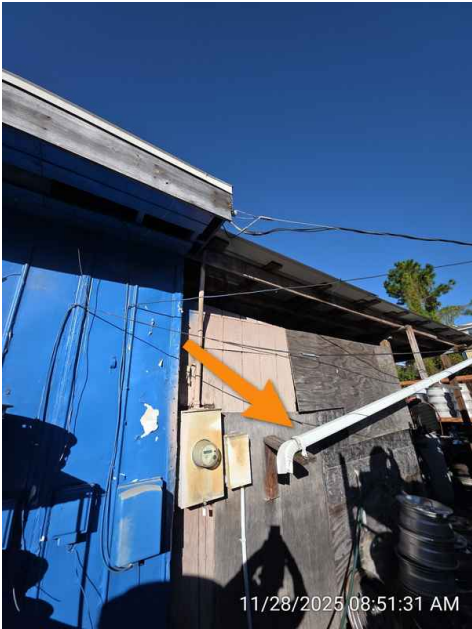
An unconventionally installed downspout was observed in the referenced area(s), which may reduce drainage efficiency or direct water too close to the foundation. Improper water management can lead to moisture intrusion or soil erosion. Recommend evaluation and correction by a licensed contractor.

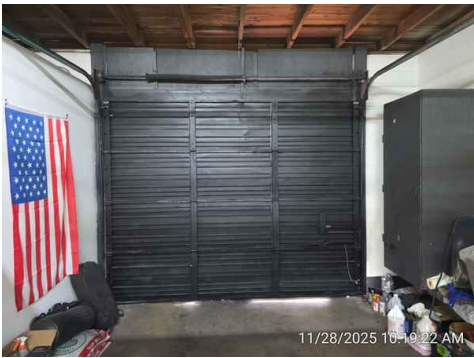
FYI - The garage door(s) were aged units. While functional at the time of inspection, replacement should be anticipated in the future due to its/their age alone.

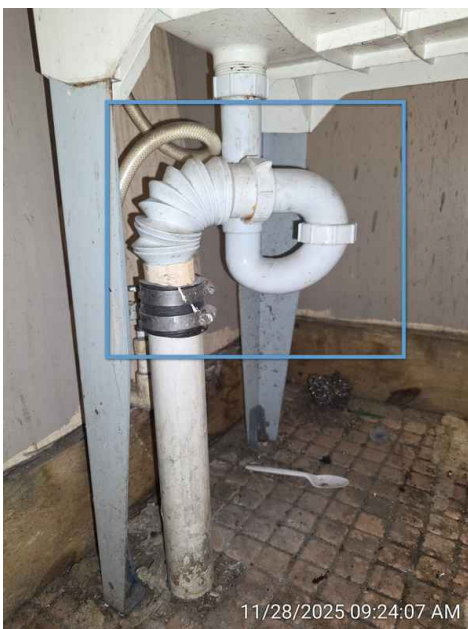
A flex drain pipe was present. Flex drain pipes are not recommended as they may clog more often and affect water drain flow. Current standards call for smooth walled drain pipes only. Replacement of the flex pipe(s) is recommended to be conducted by a licensed plumber.

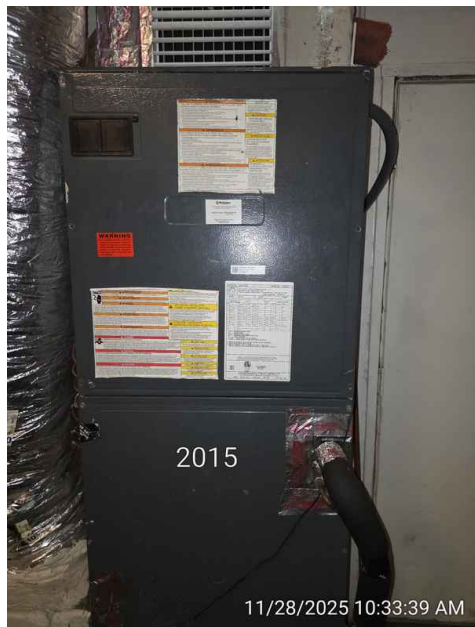
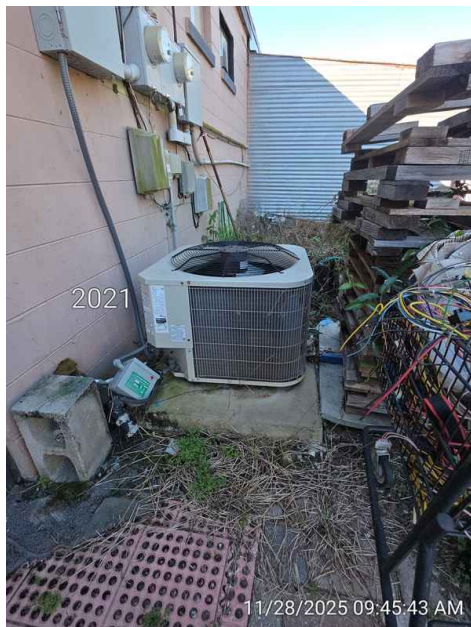
The interior and exterior HVAC units have been replaced independently, resulting in a mismatched system. This is often done for budgetary reasons, although both components are typically replaced together for optimal performance. Recommend evaluation by a licensed HVAC contractor to assess compatibility and efficiency.

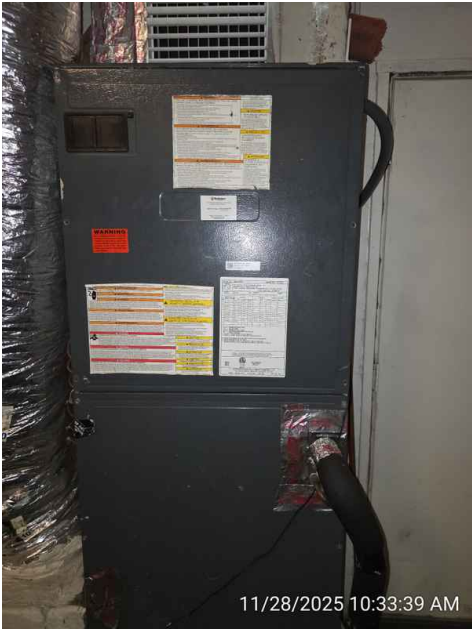
The air handler was observed to be oversized in the referenced area(s), which may result in short-cycling, inefficient operation, poor humidity control, and uneven indoor comfort. Recommend evaluation by a licensed HVAC contractor to confirm system sizing and compatibility.

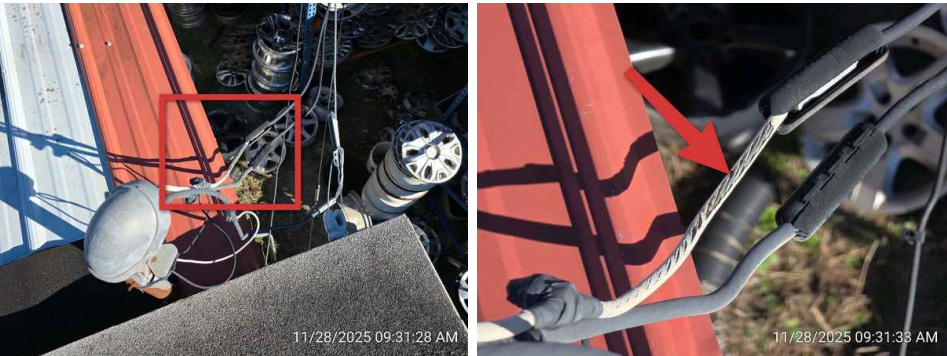
The insulating jacket(s) on the overhead conductor(s) were damaged. Repairs are recommended as needed to the conductors by a licensed electrician.

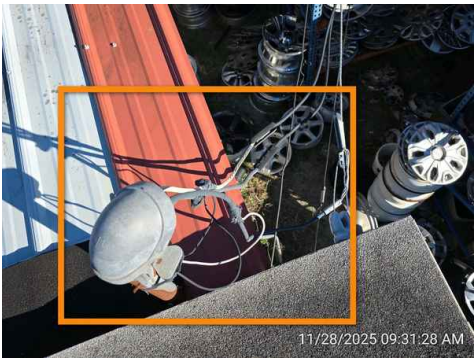
The service drop / overhead conductors were within 18 inches of the roof surface. These conductors are recommended to have 18 inches of clearance from the roof surface. Evaluation and repairs as needed is recommended by the utility provider or a licensed electrician.

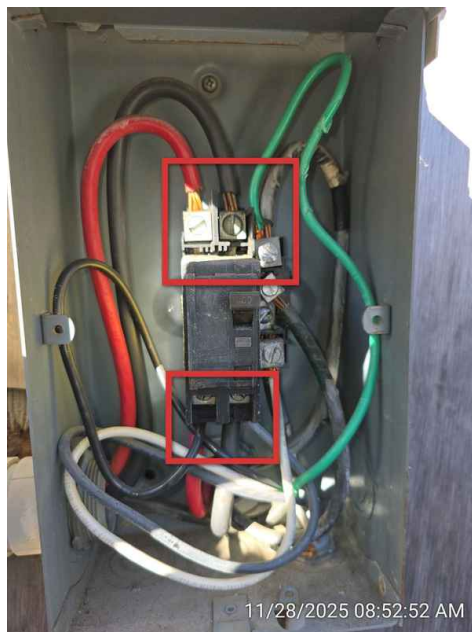
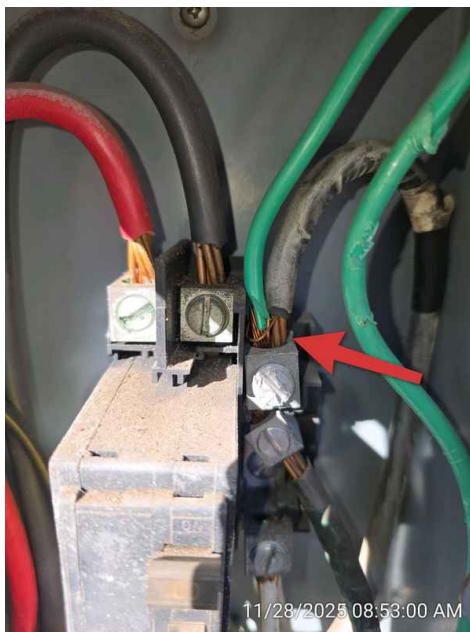
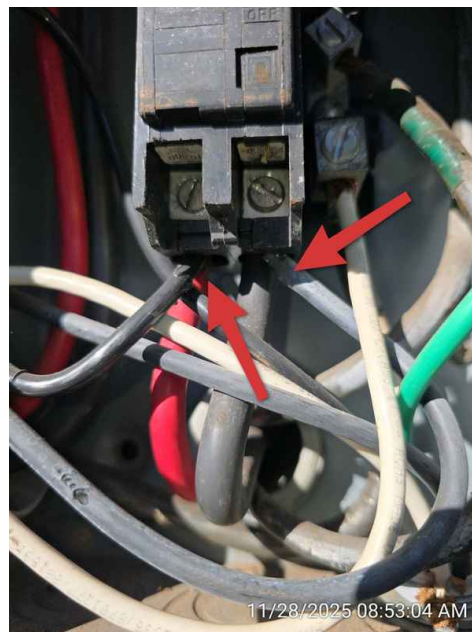
Lugs were present in the service equipment that had multiple conductors terminated under them. Most lugs are only rated for one conductor. Evaluation of the conductors with repairs made as needed is recommended by a licensed electrician.

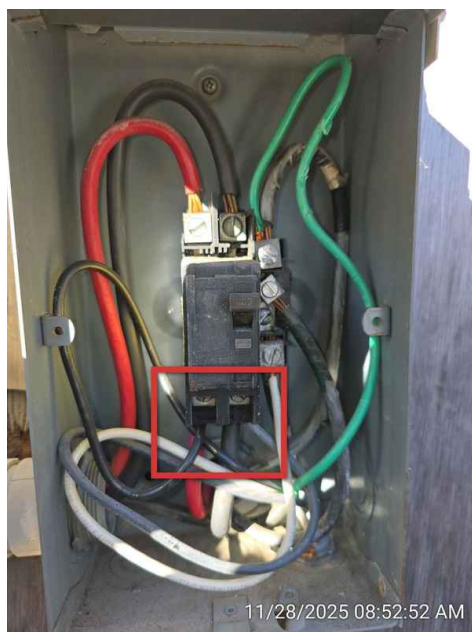
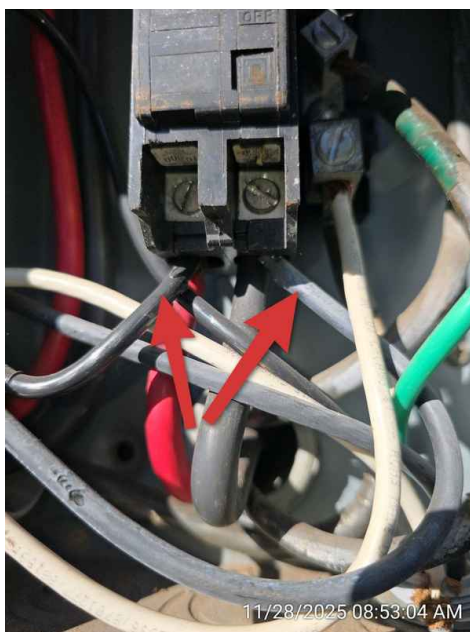
Undersized conductor(s) were observed in the main panel in the referenced area(s), which may lead to overheating or failure under load. This condition can pose a fire hazard and affect system performance. Recommend evaluation and correction by a licensed electrical contractor.

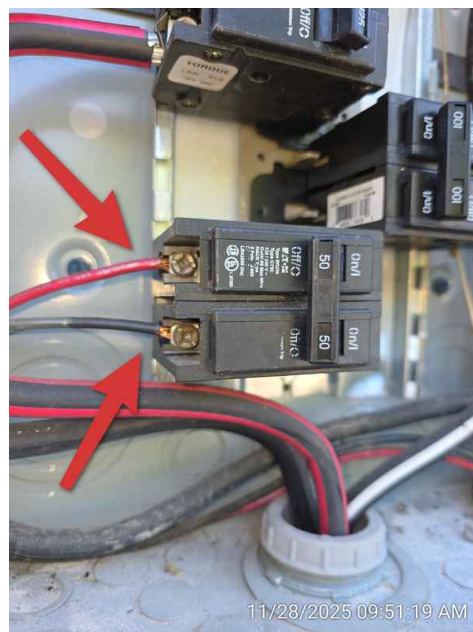
Undersized conductor(s) were observed in the main panel in the referenced area(s), which may lead to overheating or failure under load. This condition can pose a fire hazard and affect system performance. Recommend evaluation and correction by a licensed electrical contractor.

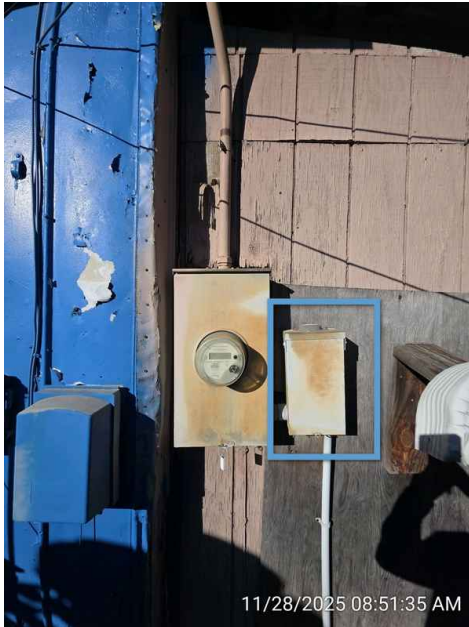
FYI - This property contained a 100amp electrical service. While common in older properties, it may be insufficient for a property of this size in today's age with all of the electrical components used today. An evaluation of the service amperage's adequacy along with load testing is recommended to be performed by a licensed electrician.

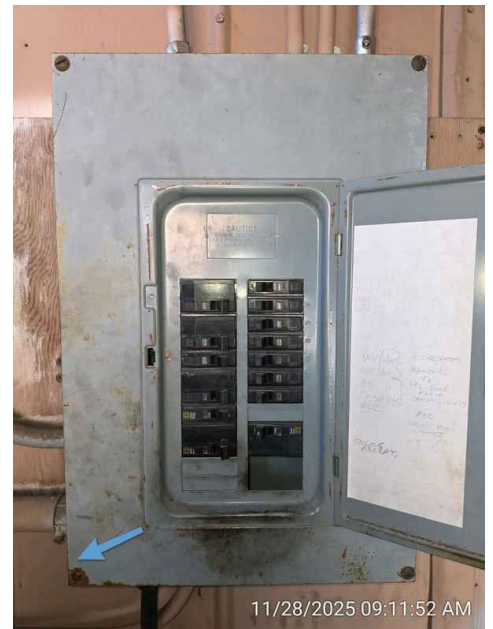
Some panel cover screw(s) were missing. All panel cover screw locations are required to be utilized to adequately secure the cover to the panel. Replacement of the screws is recommended to be conducted by a qualified person.

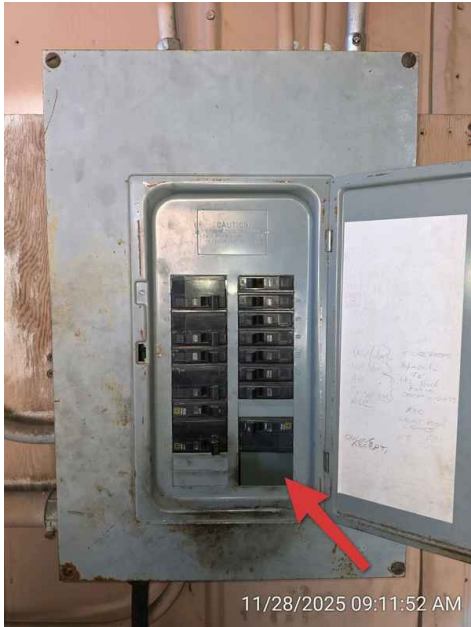
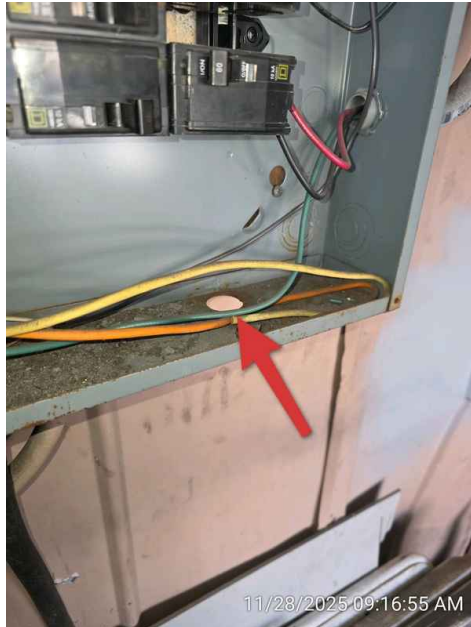
Open knockout(s) were present in the distribution panel. Knockout caps should be installed by a licensed electrician or other qualified person to keep mice out of the panel box, and to avoid a potential electrocution hazard.

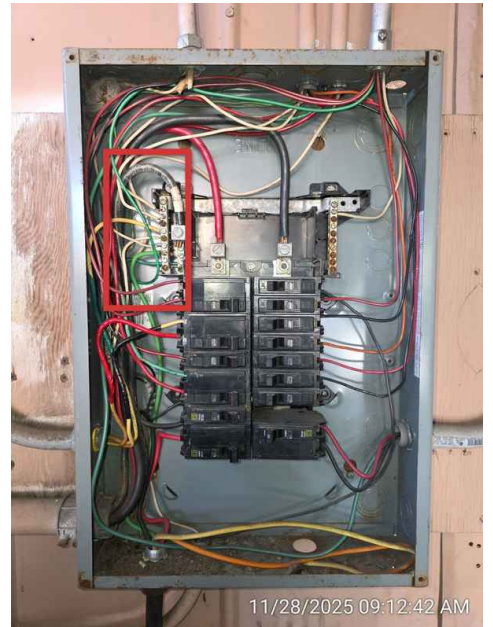
The distribution panel in the referenced area(s) contained neutrals and grounds that were not properly isolated. Improper bonding in a sub-panel can create potential shock hazards or improper circuit function. Recommend evaluation and correction by a licensed electrical contractor.

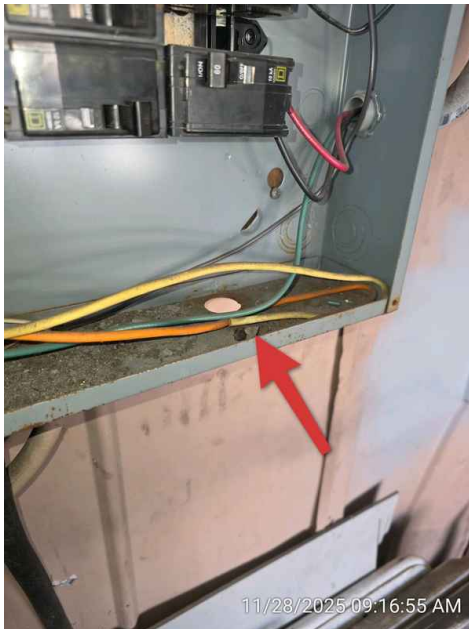
Uncapped wire termination(s) were present in the distribution panel. These should be capped/wire nipped off. Repairs are recommended to be performed as needed by a licensed electrician.

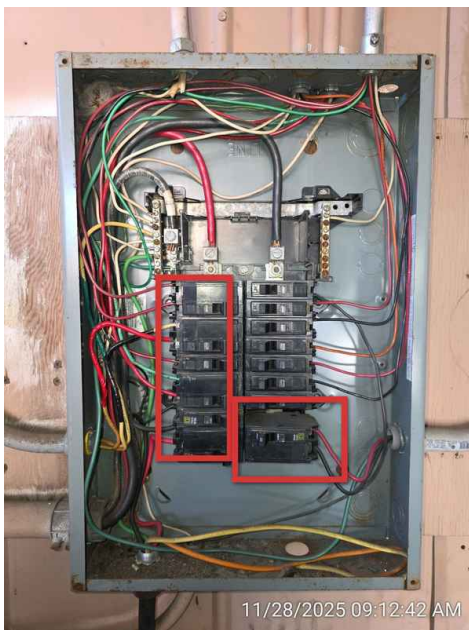
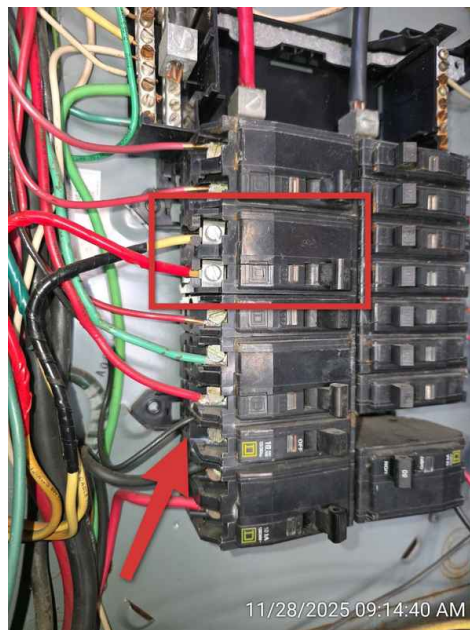
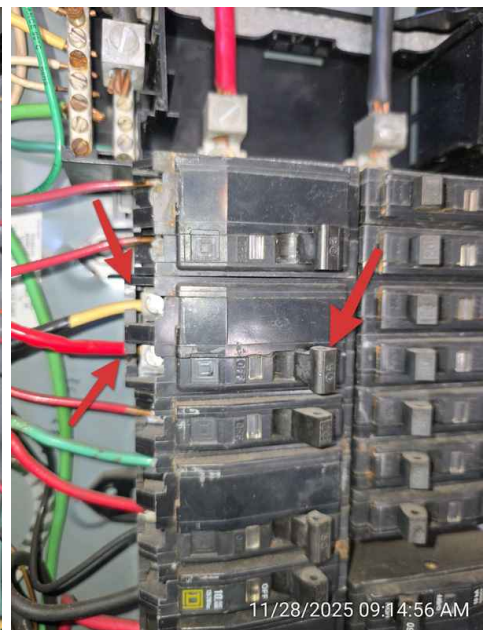
Undersized conductor(s) were observed in the main panel in the referenced area(s), which may lead to overheating or failure under load. This condition can pose a fire hazard and affect system performance. Recommend evaluation and correction by a licensed electrical contractor.

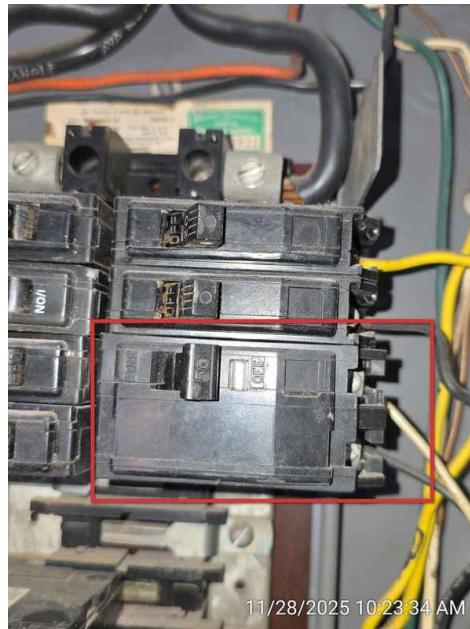
Undersized conductor(s) were observed in the main panel in the referenced area(s), which may lead to overheating or failure under load. This condition can pose a fire hazard and affect system performance. Recommend evaluation and correction by a licensed electrical contractor.

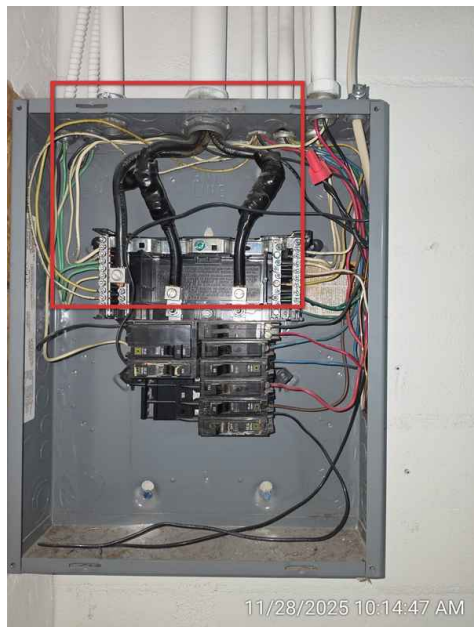
A four wire feed was not present between the main panel, and the distribution panel(s). This can prevent faults from finding their path to service or ground, and is a safety hazard. The installation of a four wire feed is recommended to be conducted by a licensed electrician.

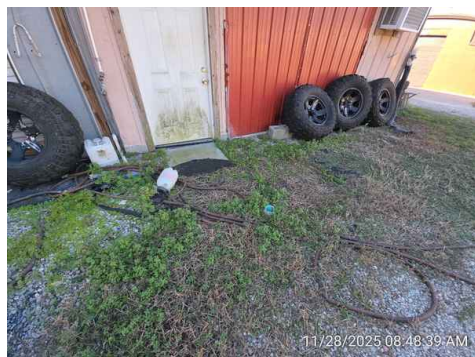
The sewer cleanout was observed to be damaged in the referenced area(s), which may hinder access for maintenance and allow debris or water intrusion. Recommend evaluation and repair by a licensed plumber.

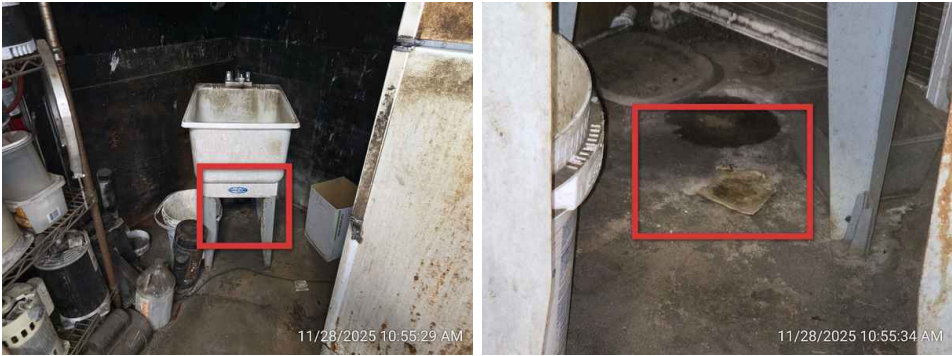
An active leak was observed under the sink in the referenced area(s), evidenced by water presence and dripping from the plumbing connections. This condition can lead to water damage, mold growth, and deterioration of surrounding materials if not promptly addressed. Immediate action is required to prevent further damage and potential health risks. Recommend repair of the leak and any water-damaged components by a licensed plumber to ensure integrity and functionality of the plumbing system.

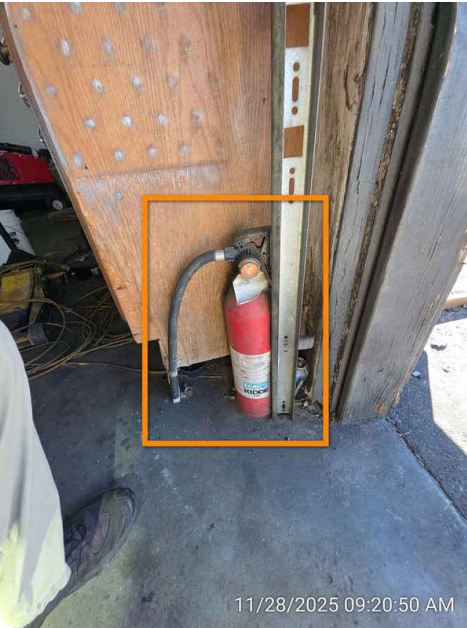
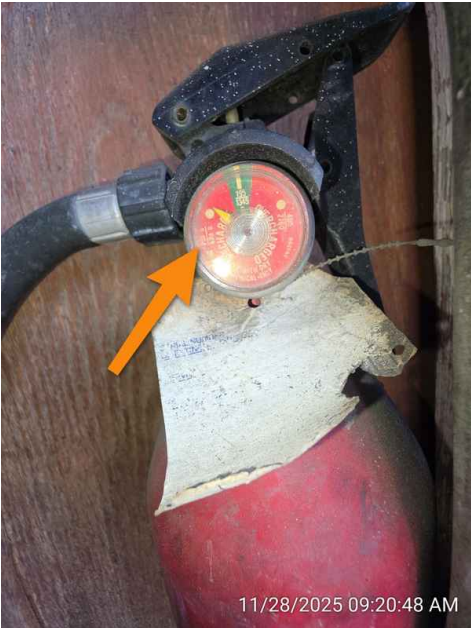
An uncharged fire extinguisher was observed in the referenced area(s), which may render it ineffective in an emergency. Recommend replacement or recharging by a qualified fire equipment service provider.

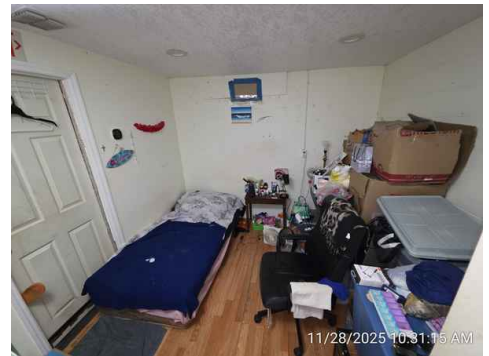
SFTY - CO alarms were not present at all locations required by today's standards. CO alarms are recommended for any property's containing gas appliances or an attached garage. The installation of CO detectors is recommended to be conducted outside of work areas by a qualified person, for safety.

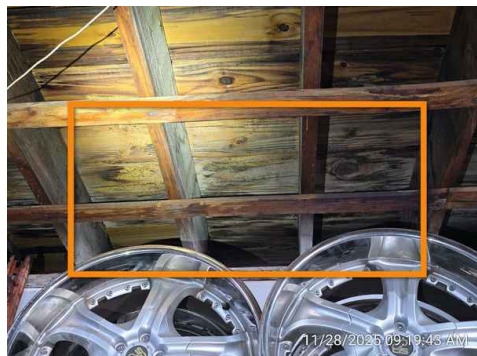
Fungal growth was observed on the referenced surface(s). This condition can contribute to poor indoor air quality and potential health concerns. It may indicate underlying moisture issues that need addressing to prevent further growth. Recommend cleaning and remediation by a licensed mold remediation contractor.

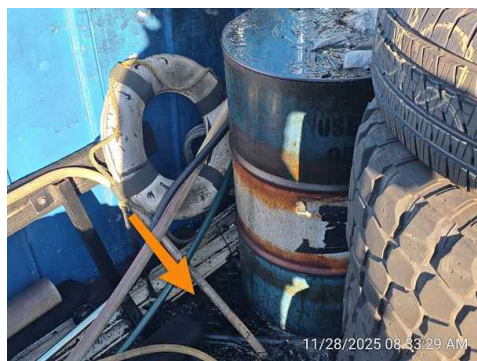
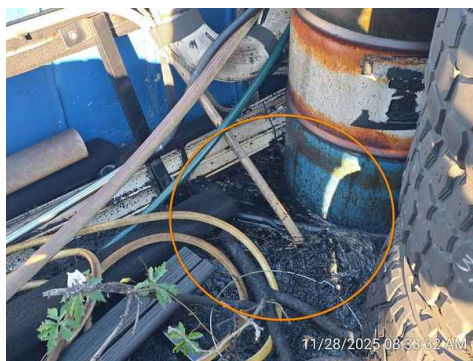
A leak was observed from the oil tank onto the ground in the referenced area(s), indicating a potential environmental hazard and compromised containment. This condition may lead to soil contamination and poses a fire risk. Recommend immediate evaluation and remediation by a licensed environmental and waste disposal contractor.
