TIER-1 PRO INSPECTIONS

COMMERCIAL PROPERTY CONDITION ASSESSMENT

1234 Main Street
Winter Springs, FL 32708

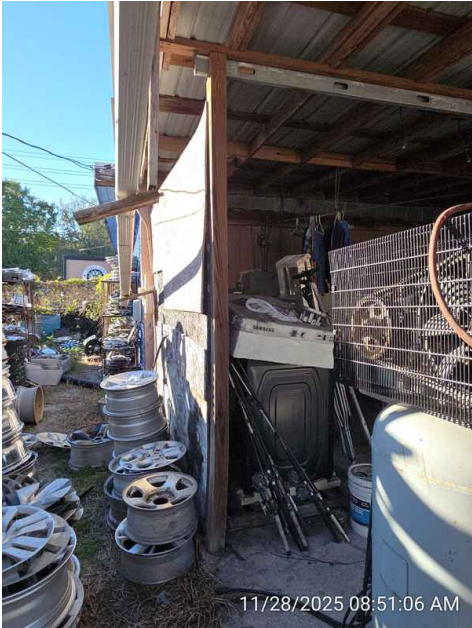
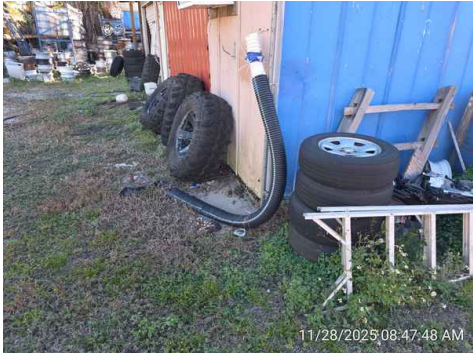
The exterior grading was relatively flat in the referenced area(s). The soil is recommended to slope away from the structure, with a 6 inch drop in elevation, in the first 10 feet away (5% grade). Evaluation of the grading in this area with repairs made as needed to allow for proper drainage and rainwater runoff is recommended by a grading contractor or other qualified person.

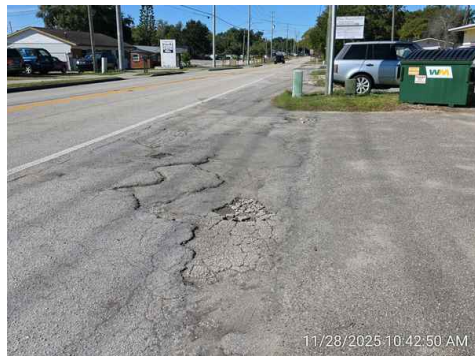
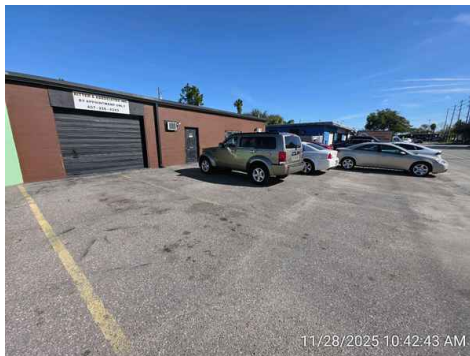
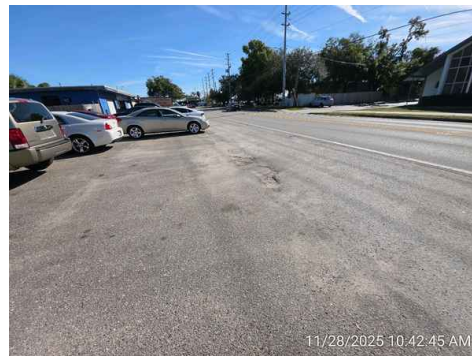
4.3.1 Parking Lot & Walkway Assessment

ASPHALT - CRACKING AND/OR DETERIORATION

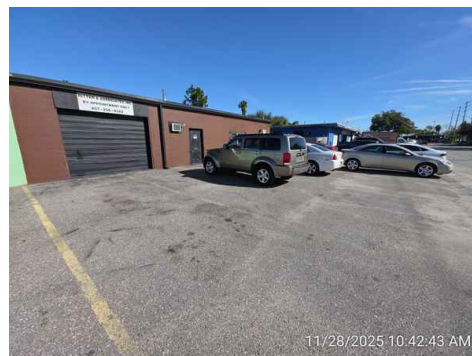
4.3.2 Parking Lot & Walkway Assessment

PARKING LOT STRIPING REQUIRED

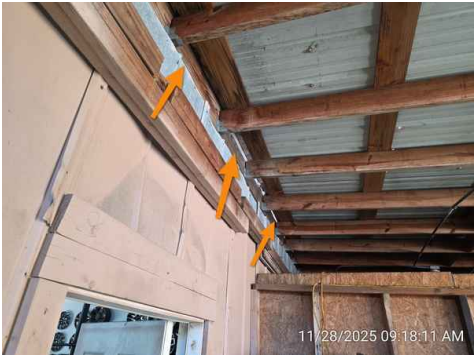
The framing member for the porch roof that attached to the fascia was not secured properly. Evaluation of this roof with repairs made as needed is recommended by a qualified person.

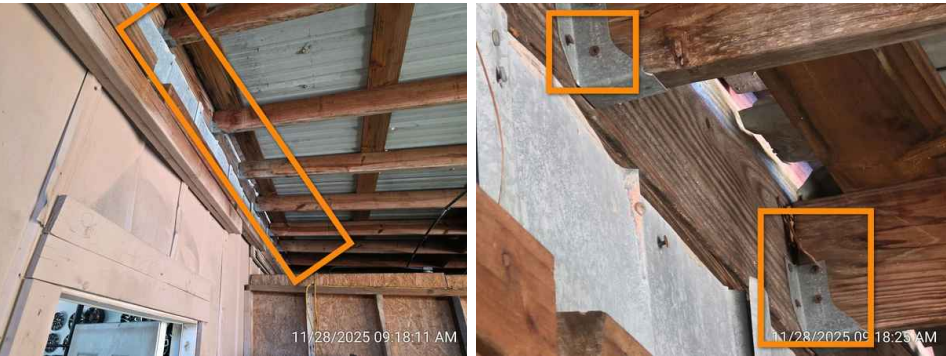
4.5.3 Porch / Deck Roof Condition

RAFTERS - HANGERS IMPROPER FASTENERS

Improper fasteners were used to secure the rafter hangers. The installation of the proper fasteners is recommended by a qualified person.

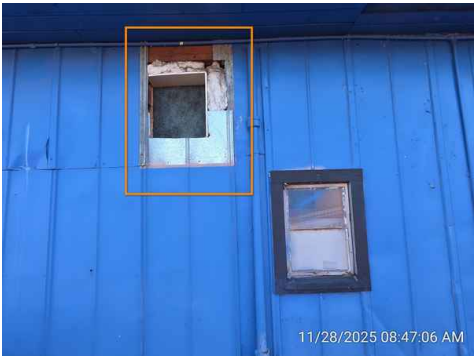
RAIN WATER ENTRY POINTS PRESENT

There were area(s) present that will allow rain water to infiltrate behind the wall cladding. An evaluation of the wall cladding is recommended to be conducted by a qualified siding contractor with repairs made as needed to prevent water infiltration behind the cladding.

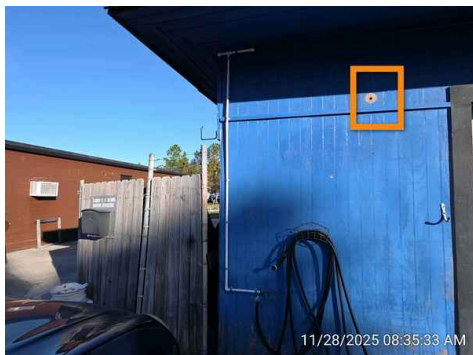
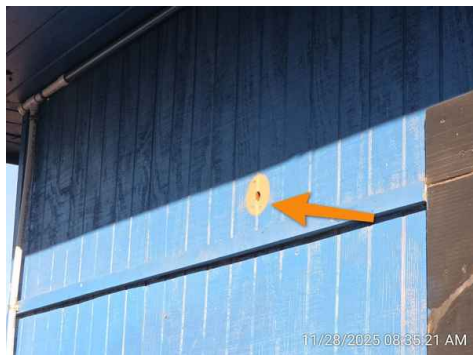
5.2.3 Walls / Cladding

GENERAL - PAST WALL INTRUSION(S) NOT SEALED

There were area(s) present where an item was previously protruding through a wall, that was not sealed or flashed properly after removal. Properly repairing or sealing these area(s) as needed is recommended to be conducted by a qualified contractor to prevent moisture and insect infiltration.

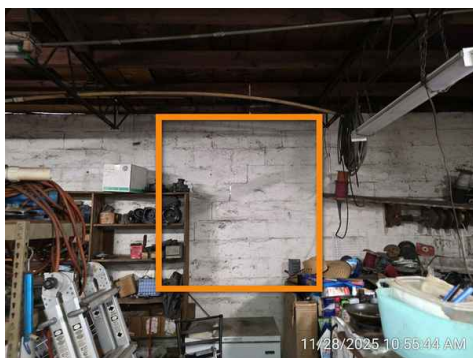
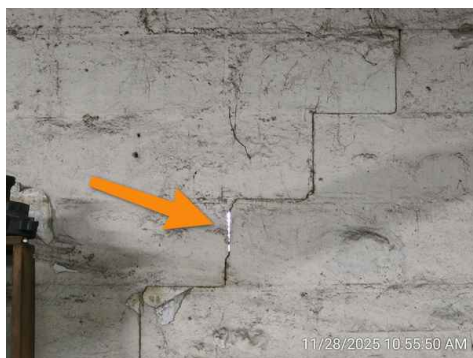
5.2.4 Walls / Cladding

CRACKING - SIGNIFICANT SETTLEMENT

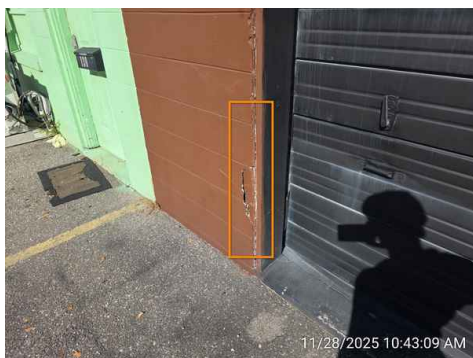
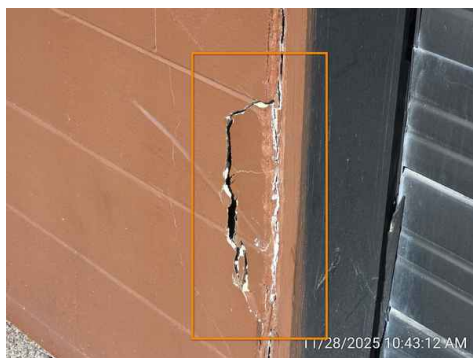
5.2.5 Walls / Cladding

CMU BLOCK - DAMAGED

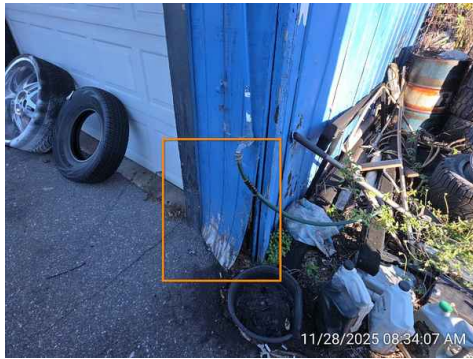
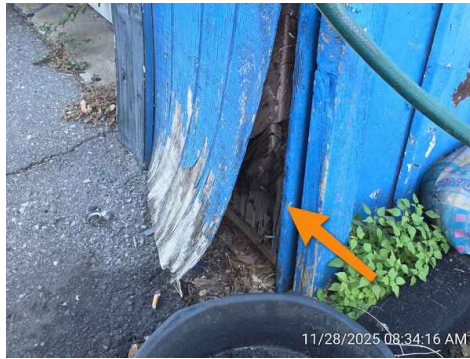
5.3.1 Wood Siding

WOOD - SIDING CUPPED/CHECKED

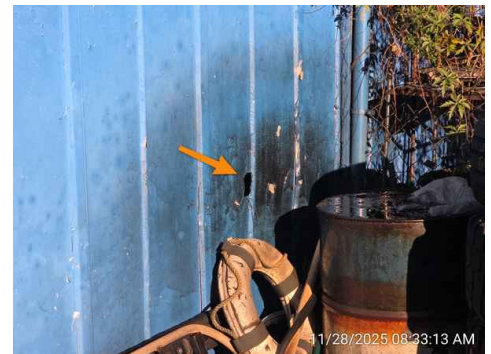
5.4.1 Metal Siding

METAL SIDING - HOLE PRESENT

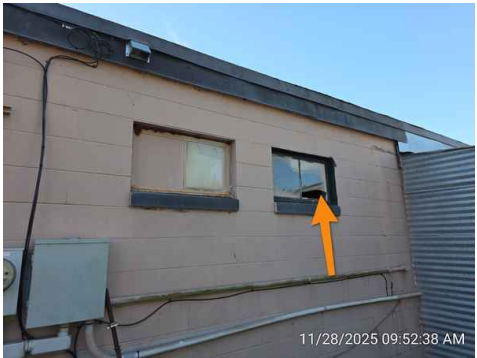
5.5.2 Exterior Windows

GLASS - BROKEN / CRACKED

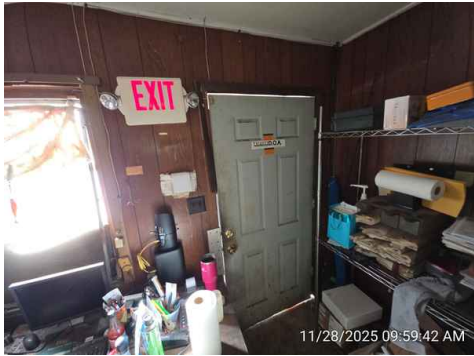
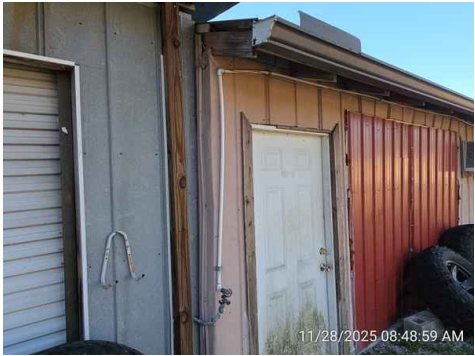
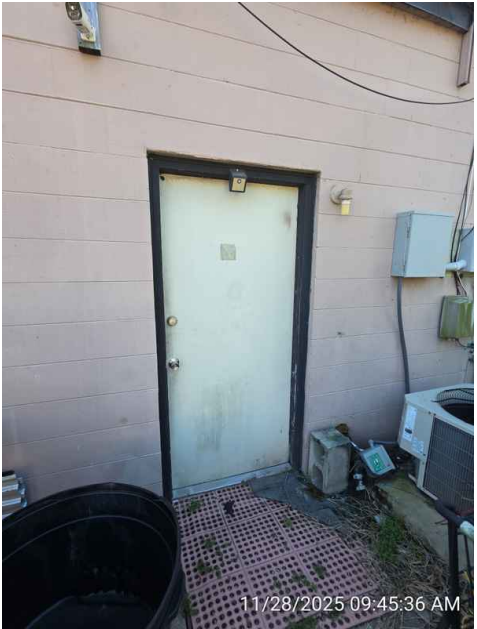
5.6.1 Exterior Doors

GENERAL - DAMAGE PRESENT TO DOOR(S) (MULTIPLE DEFICIENCIES)

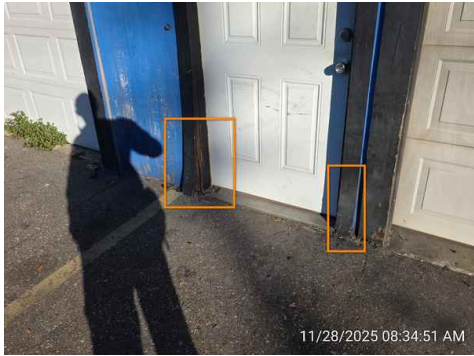
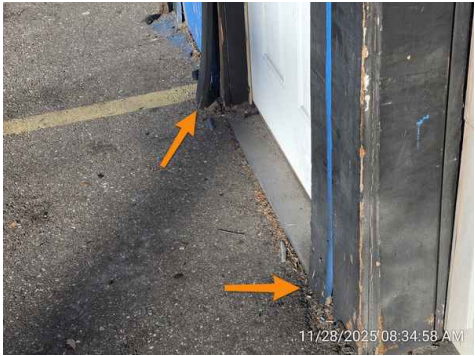
5.6.2 Exterior Doors

WOOD - WATER DAMAGE PRESENT

Some degree of water damage was present to wooden components of the door jambs, door slab, and/or brick moulding of the referenced door(s). Repairs or replacement to correct any damaged wood is recommended to be conducted as needed by a contractor or other qualified person, with sealing or modifications made to prevent further/future damage. The possibility of hidden framing damage being present under the threshold exists and should be investigated and repaired at this time.

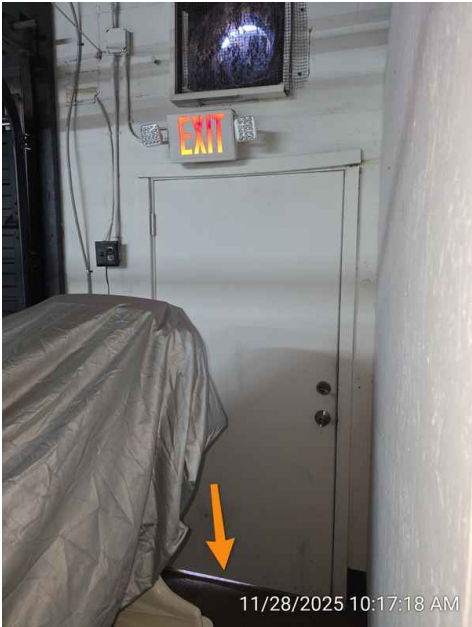
5.6.3 Exterior Doors

LIGHT VISIBLE - UNDER DOOR

Light was visible under the door while in the closed position. Adjustments or modifications as needed is recommended to be conducted by a qualified person to eliminate any visible light.

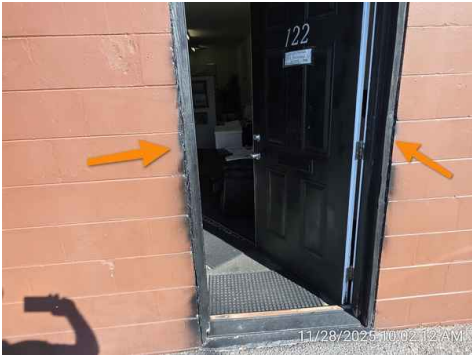
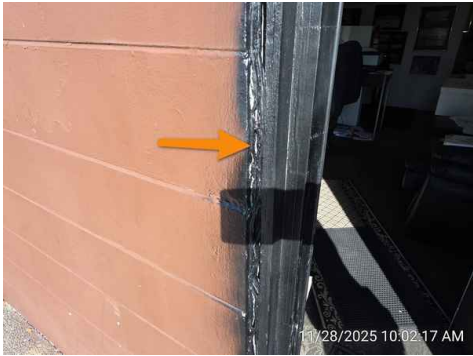
5.6.4 Exterior Doors

Gaps were observed between the exterior door frame and adjacent cladding in the referenced area(s). These gaps may allow water intrusion, pest entry, or energy loss. Recommend sealing and evaluation by a licensed contractor.

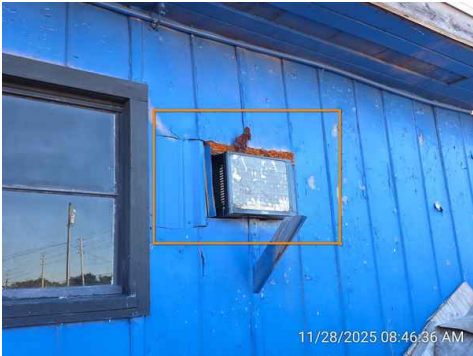
GENERAL - MISSING FLASHING

There were areas on the wall that were missing flashing. These areas can allow for water infiltration behind the cladding and hidden damage may be present at these areas. An evaluation of the wall cladding with repairs made to prevent water infiltration and repairs made to any damage is recommended to be conducted by a qualified contractor.

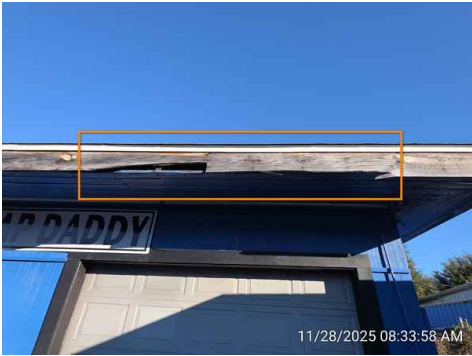
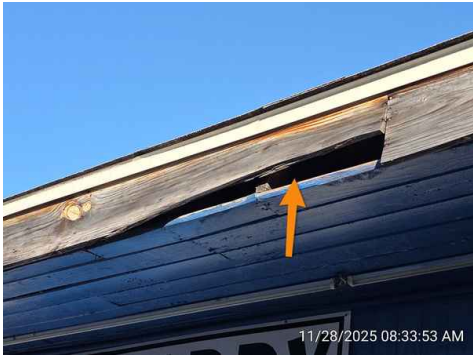
Short-Term Future Costs**FASCIA - DAMAGED**

Damaged fascia was observed in the referenced area(s), including visible deterioration and possible water exposure. This condition may allow further moisture intrusion, pest entry, or compromise the attachment of gutters and roofing materials. Recommend evaluation and repairs by a licensed roofing contractor.

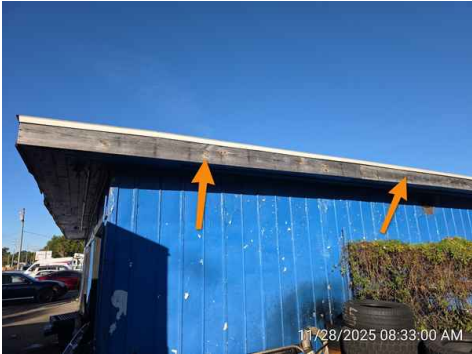
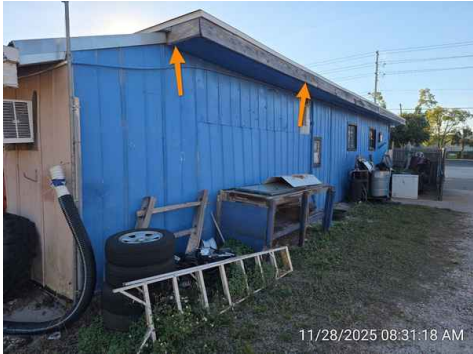
WOOD - WEATHERED (NEGLECT)

Weathered wood was present to portions of the siding, windows, trim, and/or fascia. This appeared to be from a lack of maintenance over the years. Repainting is recommended and during this process there will more than likely be weather related damage found which should be repaired or replaced as needed by a qualified person.

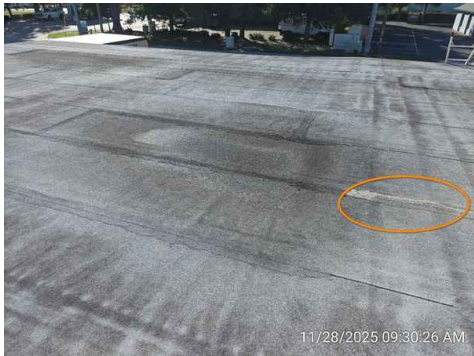
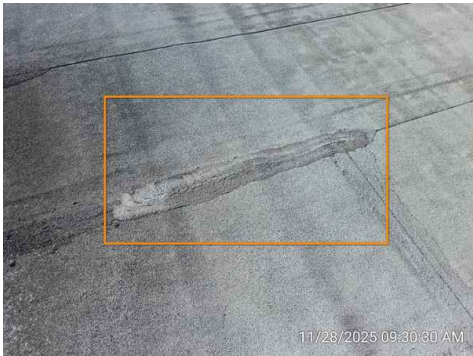
MODIFIED BITUMEN - PRIOR REPAIRS PRESENT

There were prior repairs made to area(s) of the roof surface. I recommend consulting with the Prior repairs were observed on the modified bitumen roofing in the referenced area(s), including patches or sealant application. While no active leaks were confirmed, past repairs may indicate previous issues. Recommend evaluation by a licensed roofing contractor to assess current condition and integrity.as to why this was done as well as obtaining any applicable invoices, etc. This is typically indicative of past leaking.

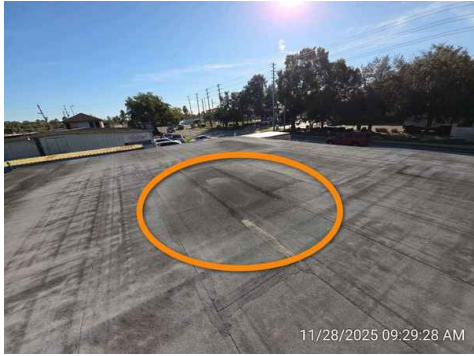
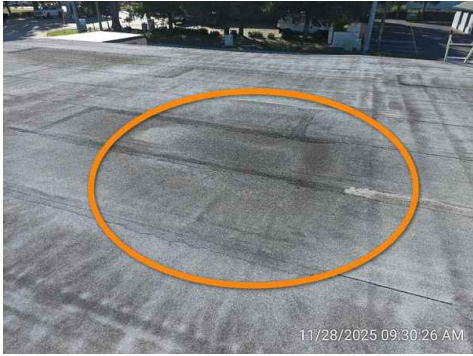
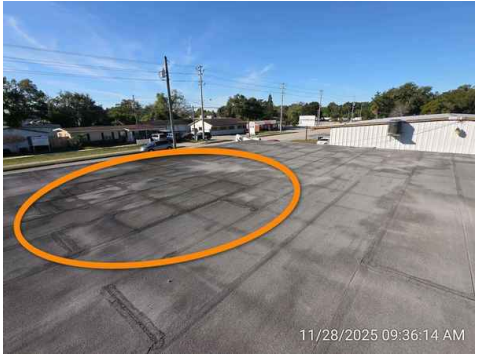
Bldg 1

MODIFIED BITUMEN ROOFING - EVIDENCE OF PONDING PRESENT

Evidence of ponding water was observed on the referenced modified bitumen roofing. Prolonged water accumulation can accelerate membrane deterioration, increase the risk of leaks, and reduce the roofing system’s lifespan. Recommend evaluation and necessary corrective actions by a licensed roofing contractor to improve drainage and prevent further issues.

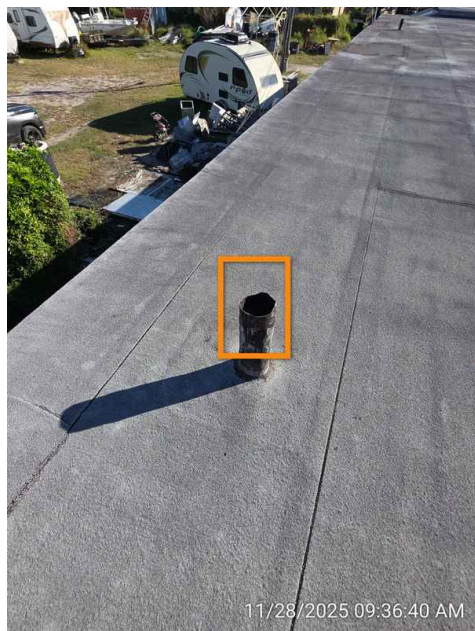
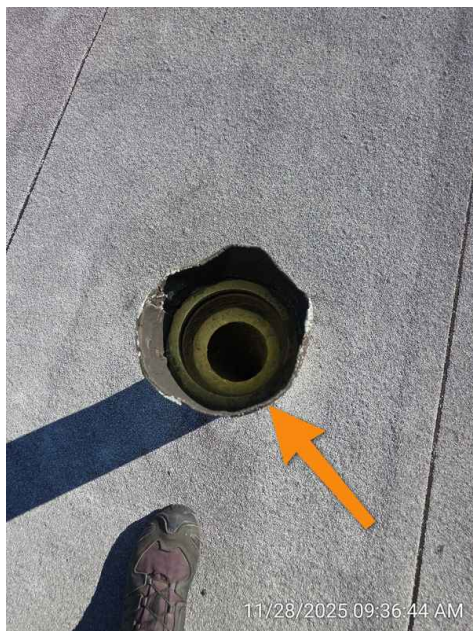
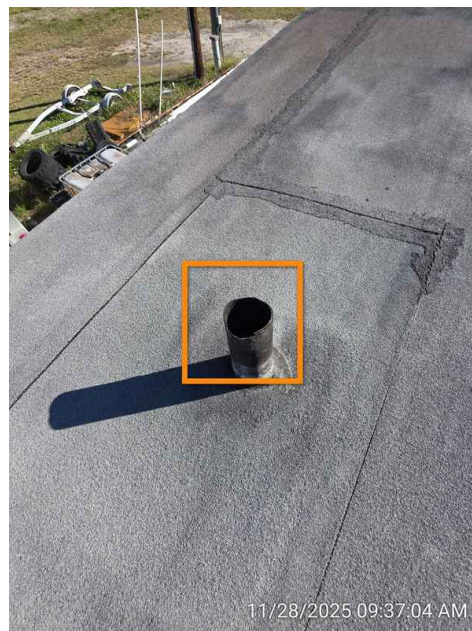
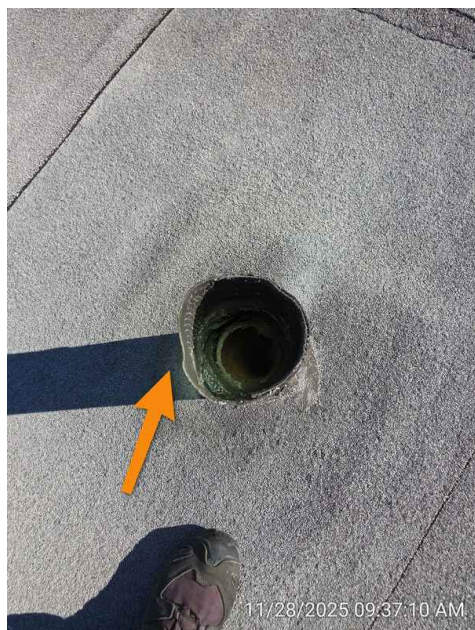
LEAD WRAP - IMPROPERLY INSTALLED

Improperly installed lead wrap was observed at roof vent(s) in the referenced area(s), including lifting or misalignment. This condition may allow water intrusion and accelerate roof material deterioration. Recommend evaluation and correction by a licensed roofing contractor.

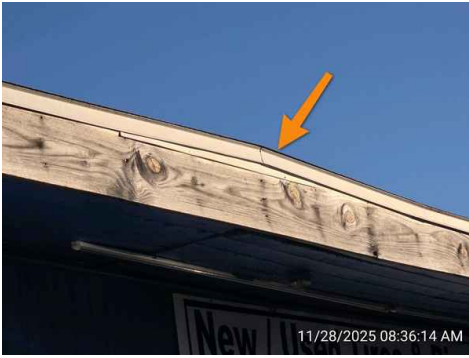
DRIP EDGE - DISPLACED

The drip edge flashing was displaced at the referenced area(s). Repairs to the drip edge flashing to secure it is recommended to be conducted by a qualified roofing contractor.

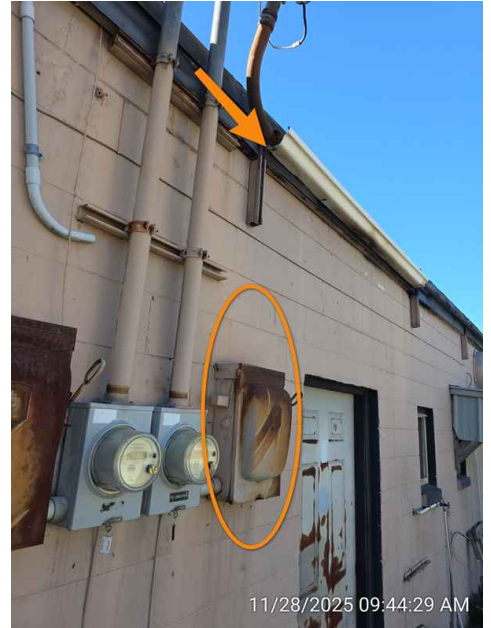
GUTTER(S) - ENDCAP MISSING

The guttering at the referenced area was missing an endcap. This will allow rainwater to flow out of the end of the gutter. The installation of an endcap is recommended to be installed by a qualified person.

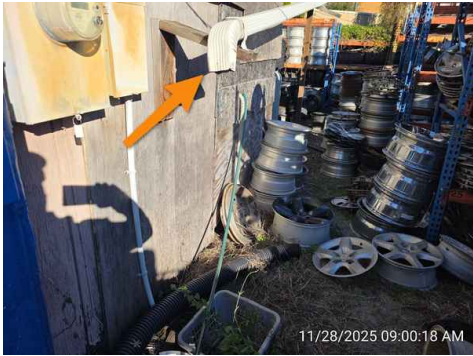
DOWNSPOUT - UNCONVENTIONAL INSTALLATION

An unconventionally installed downspout was observed in the referenced area(s), which may reduce drainage efficiency or direct water too close to the foundation. Improper water management can lead to moisture intrusion or soil erosion. Recommend evaluation and correction by a licensed contractor.

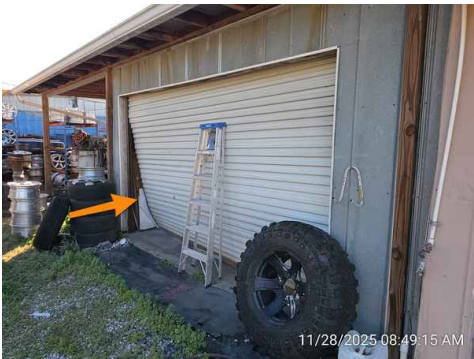
ROLL-UP DOOR - DAMAGED
NOT FUNCTIONAL

The roll-up garage door was observed to be damaged and not operational in the referenced area(s). This condition may present safety concerns, reduce security, and limit access or egress. Recommend evaluation and repair by a licensed garage door contractor.

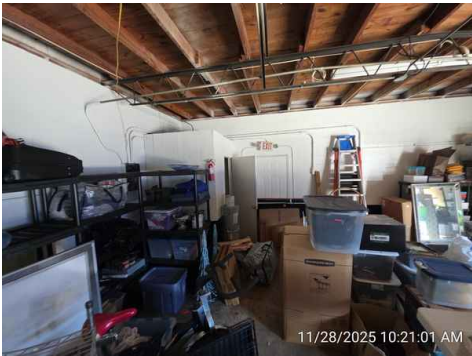
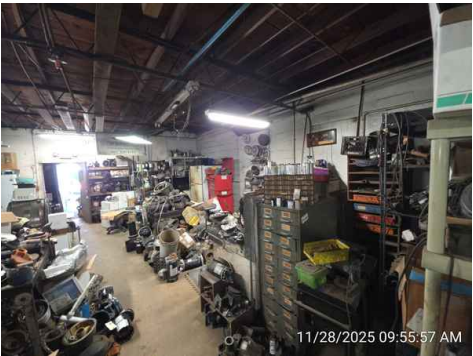
HEAVY WEAR AND TEAR THROUGHOUT THE PROPERTY

There was heavy wear and tear to wall, floor, and/or ceiling coverings throughout portions of the property, of the type generally resulting from age and heavy use. We make no attempt to list all cosmetic flaws. Appropriate contractors are recommended to evaluate all cosmetic deficiencies and quote repairs or replacement of items as needed.

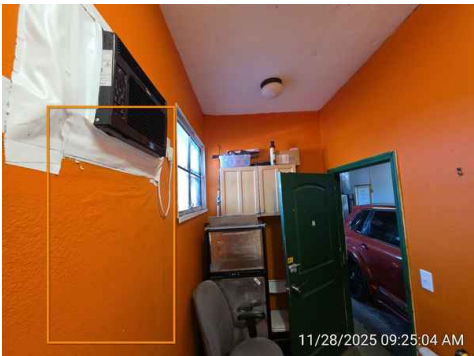
MOISTURE INFO - INDICATIONS OF MOISTURE (NO ELEVATED MOISTURE CONTENT)

Indications of moisture were present on the referenced wall(s). These area(s) were tested for moisture content and acceptable levels were present at the time of inspection. We recommend inquiring with the seller(s) about the area(s), and what repairs were carried out to address the moisture. Repairs or replacement of any affected building materials is recommended to be performed by a qualified contractor.

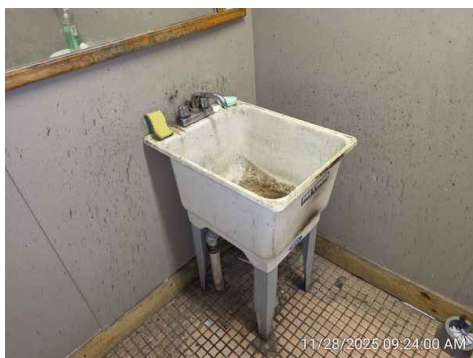
DRAIN PIPES - FLEX DRAIN PIPE PRESENT

A flex drain pipe was present. Flex drain pipes are not recommended as they may clog more often and affect water drain flow. Current standards call for smooth walled drain pipes only. Replacement of the flex pipe(s) is recommended to be conducted by a licensed plumber.

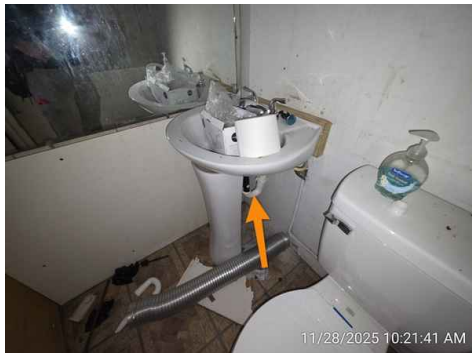
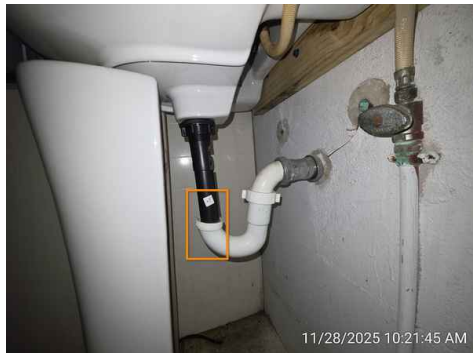
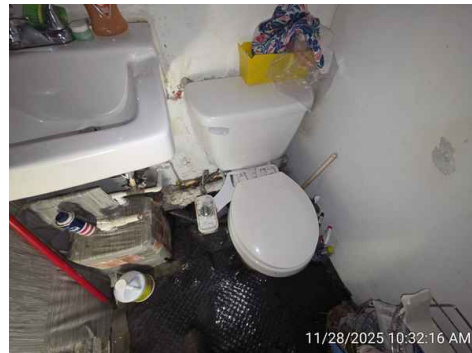
Unit 120

UNCONVENTIONAL PLUMBING PRESENT

The plumbing was installed in an unconventional manner or had unconventional materials present. An evaluation of the plumbing with repairs made as needed is recommended by a licensed plumber.

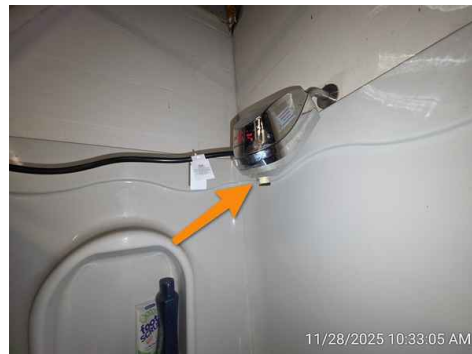
Unit 130

SHOWER HEAD - NOT PRESENT

A showerhead was not present. The installation of a showerhead is recommended to be performed here by a qualified person.

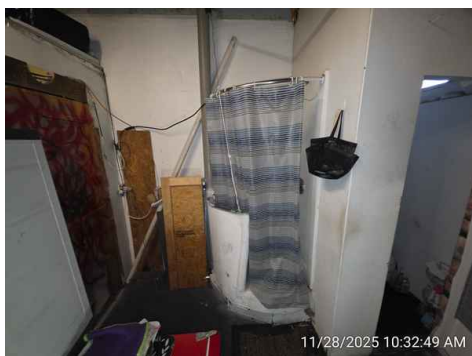
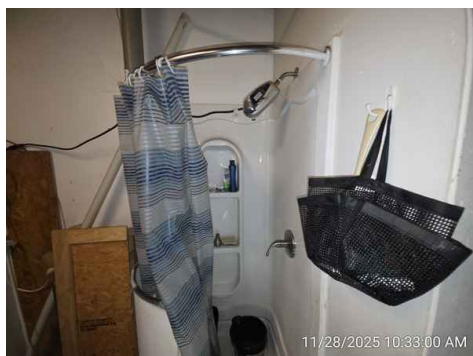
An unconventional shower installation was observed in the referenced area(s), which may affect drainage, water containment, or long-term durability. Recommend evaluation by a licensed plumbing or general contractor for safety and functionality.

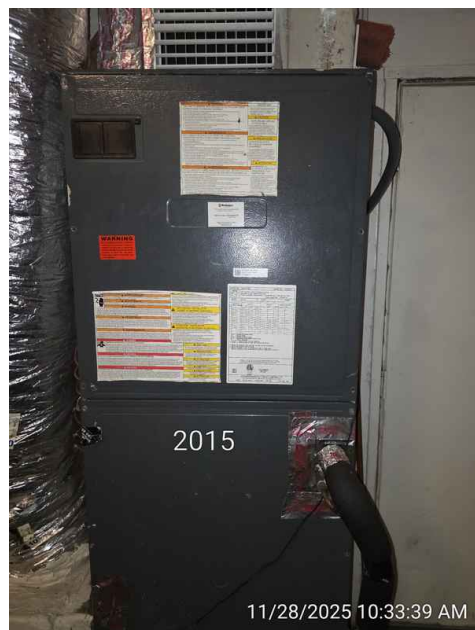
AGED - The unit was at or past its typical service life. This deficiency will be labeled in **Blue** if between 7 and 14yrs old and **Orange** if over 15yrs of age. Major repairs or replacements should be anticipated in the future due to the unit(s) age. Depending on prior maintenance and other factors, the unit(s) could last anywhere from months to years. The remaining life is undeterminable. ***Due to its age, servicing is recommended to be conducted by an HVAC contractor.*** A typical life expectancy chart can be found here:

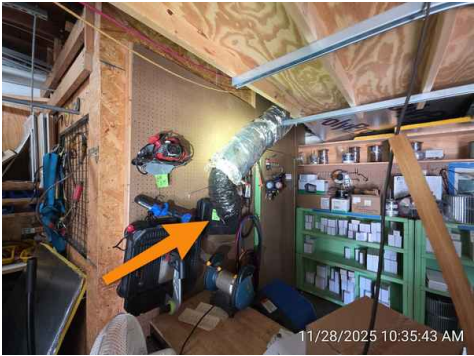
UNIT 130

DUCTWORK - FULL EVALUATION RECOMMENDED

Incomplete ductwork installation was observed in the referenced area(s), which may lead to reduced airflow, energy inefficiency, or poor indoor air quality. Recommend evaluation and completion by a licensed HVAC contractor.

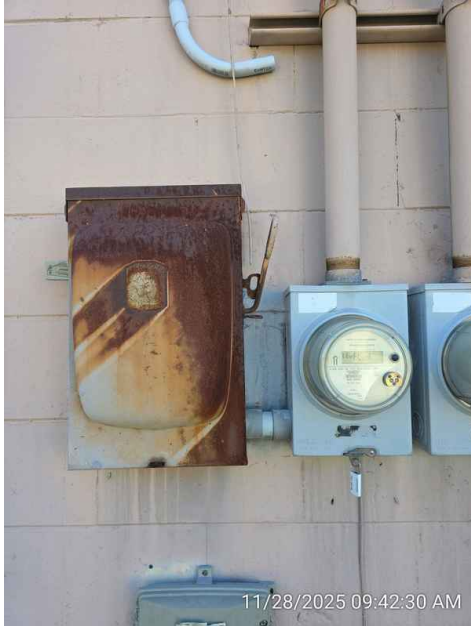
Short-Term Future Costs**PANEL - AGED (>40 YEARS)**

AGED - The electrical panel in the property appeared to be more than 40 years old. Electrical panels are one of the most important components in the property in my opinion due to the possibility of age related defects creating a safety and/or fire hazard. Any panels over 40 years of age are recommended to be evaluated by a licensed electrician to ensure they are performing as intended. Panelboards 40 - 50 or more years old should also be upgraded/changed-out at your earliest convenience as panels manufactured in recent years are inherently safer due to more rigorous testing, safety features, etc. Below is a link to a document by the Casualty Underwriters Association of America and their view on aged panels.<https://www.cauinsure.com/Include/Documents/P11%20-%20Aging%20Electrical%20Systems.pdf>

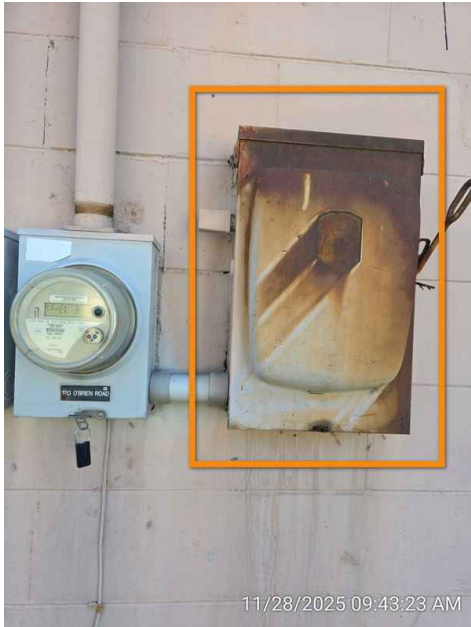
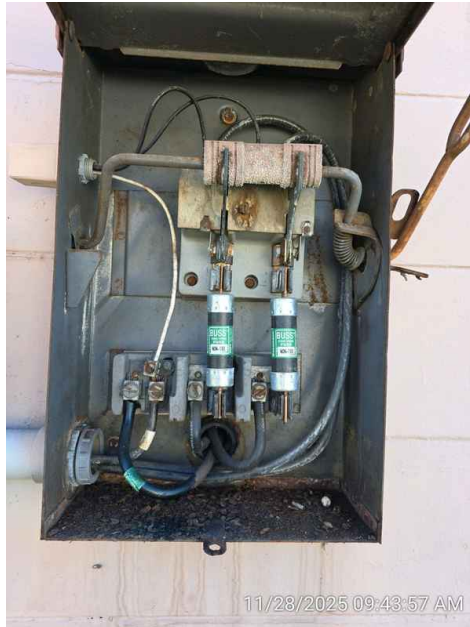
11.6.1 Main Service Panel - Unit 122

Short-Term Future Costs**PANEL - AGED (>40 YEARS)**

AGED - The electrical panel in the property appeared to be more than 40 years old. Electrical panels are one of the most important components in the property in my opinion due to the possibility of age related defects creating a safety and/or fire hazard. Any panels over 40 years of age are recommended to be evaluated by a licensed electrician to ensure they are performing as intended. Panelboards 40 - 50 or more years old should also be upgraded/changed-out at your earliest convenience as panels manufactured in recent years are inherently safer due to more rigorous testing, safety features, etc. Below is a link to a document by the Casualty Underwriters Association of America and their view on aged panels.<https://www.cauinsure.com/Include/Documents/P11%20-%20Aging%20Electrical%20Systems.pdf>

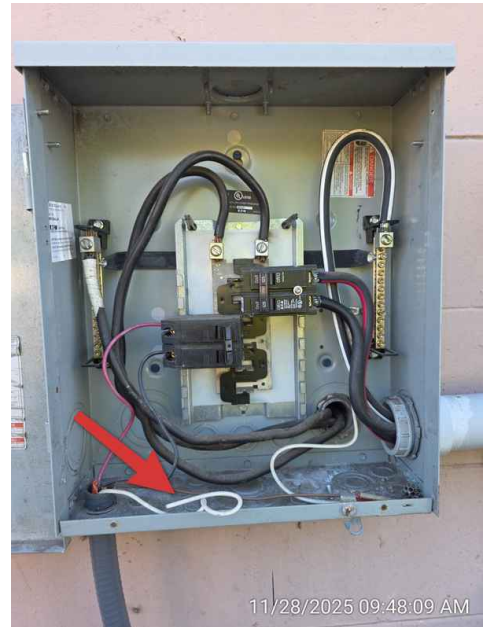
11.7.1 Main Service Panel - Unit 130

WIRING - UNCAPPED WIRE TERMINATION(S)

Uncapped wire termination(s) were present in the electrical panel. These should be capped/wire nipped off. Repairs are recommended to be performed as needed by a licensed electrician.

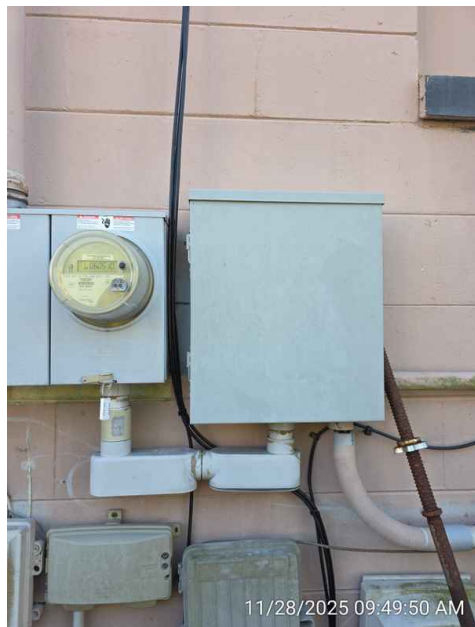
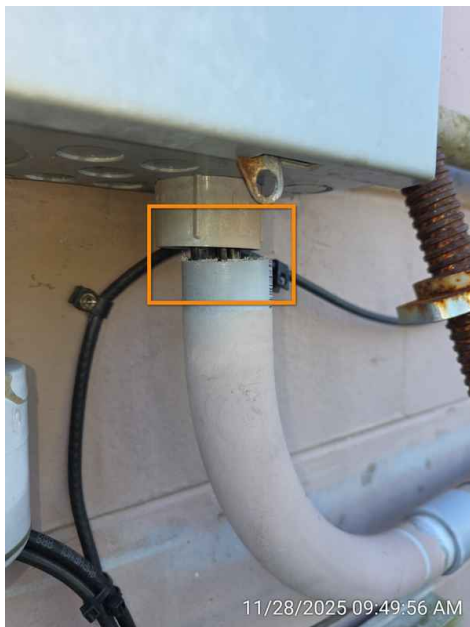
11.8.1 Main Service Panel - Unit 140

CONDUIT - DISPLACED

Displaced conduit was observed at the main panel in the referenced area(s), which may expose conductors to physical damage or reduce support for wiring. Recommend evaluation and repair by a licensed electrical contractor.

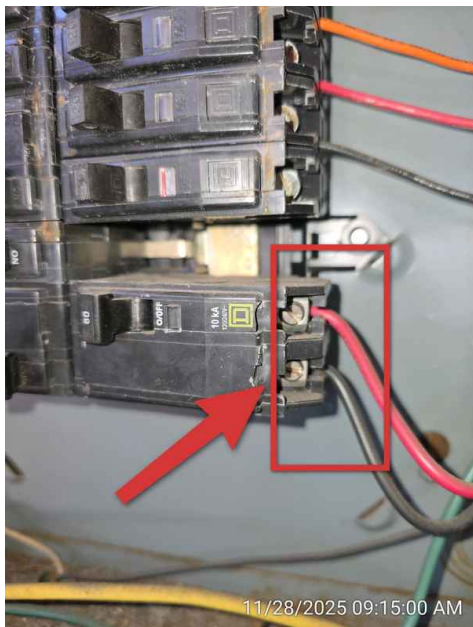
Undersized conductor(s) were observed in the main panel in the referenced area(s), which may lead to overheating or failure under load. This condition can pose a fire hazard and affect system performance. Recommend evaluation and correction by a licensed electrical contractor.

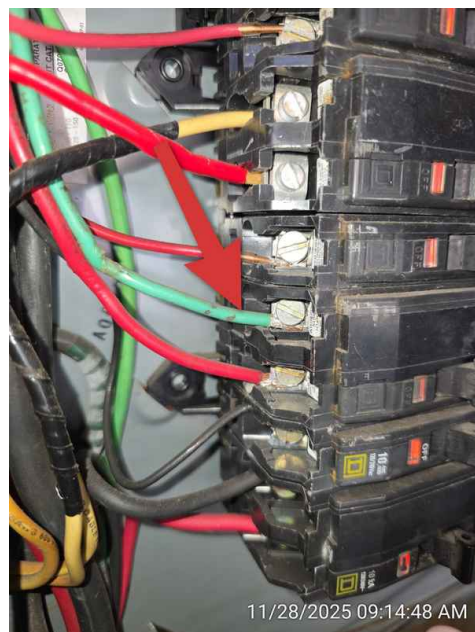
11.11.6 Distribution Panel Unit 110

GROUND - REPURPOSED TO HOT CONDUCTOR

A ground wire was observed to be repurposed as a hot conductor in the referenced area(s). This practice is unsafe, may violate applicable electrical standards, and can pose shock or fire hazards. Recommend evaluation and correction by a licensed electrical contractor.

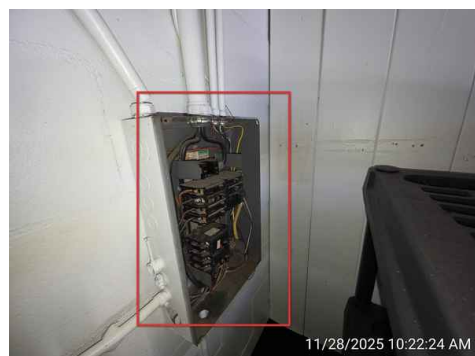
11.12.1 Distribution Panel Unit 120

COVER - MISSING

The panel cover was missing or not installed for the distribution panel. This is an electrocution hazard as this exposes panel wiring. Replacement or installation of the cover is recommended by a licensed electrician.

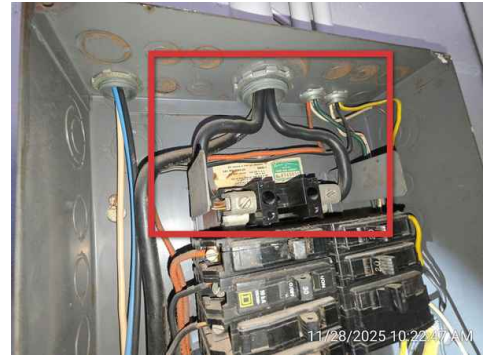
11.12.2 Distribution Panel Unit 120

PANEL - FOUR WIRE FEED MISSING

A four wire feed was not present between the main panel, and the distribution panel(s). This can prevent faults from finding their path to service or ground, and is a safety hazard. The installation of a four wire feed is recommended to be conducted by a licensed electrician.

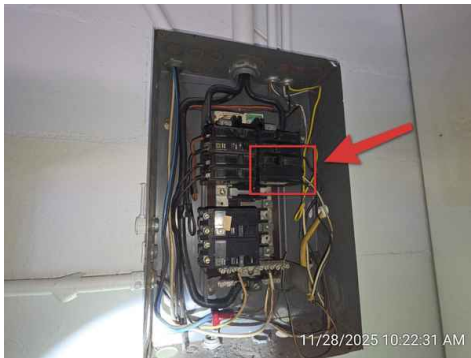
11.12.3 Distribution Panel Unit 120

CONDUCTOR(S) - UNDERSIZED

Undersized conductor(s) were observed in the main panel in the referenced area(s), which may lead to overheating or failure under load. This condition can pose a fire hazard and affect system performance. Recommend evaluation and correction by a licensed electrical contractor.

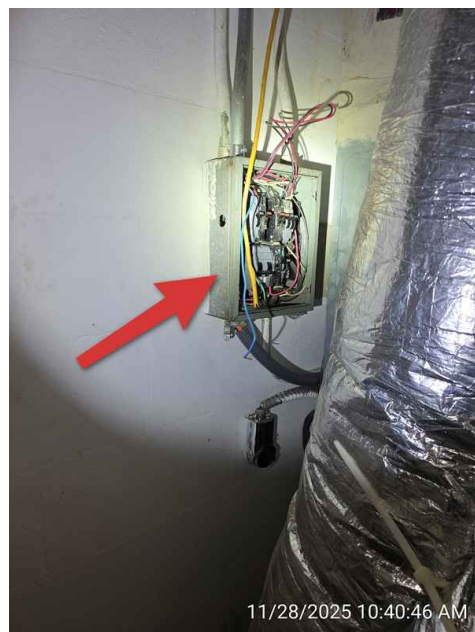
COVER - MISSING

The panel cover was missing or not installed for the distribution panel. This is an electrocution hazard as this exposes panel wiring. Replacement or installation of the cover is recommended by a licensed electrician.

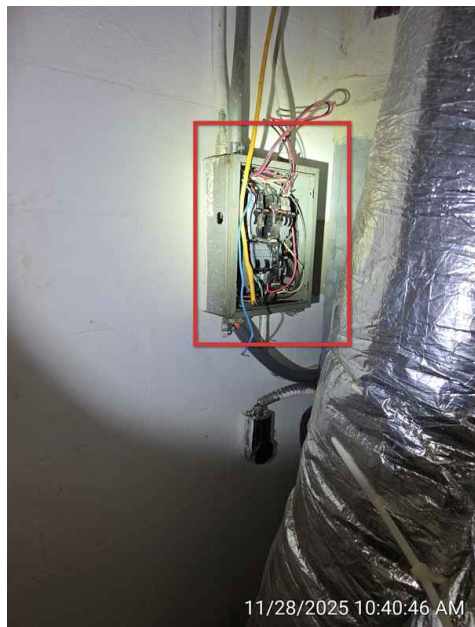
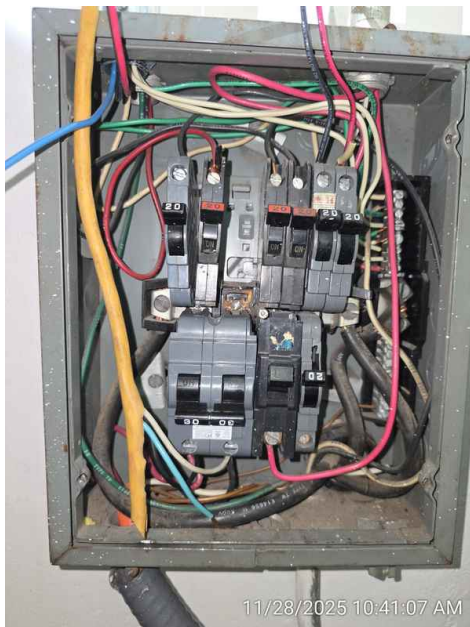
11.14.2 Distribution Panel Unit 130

PANEL - FEDERAL PACIFIC ELECTRIC PANEL

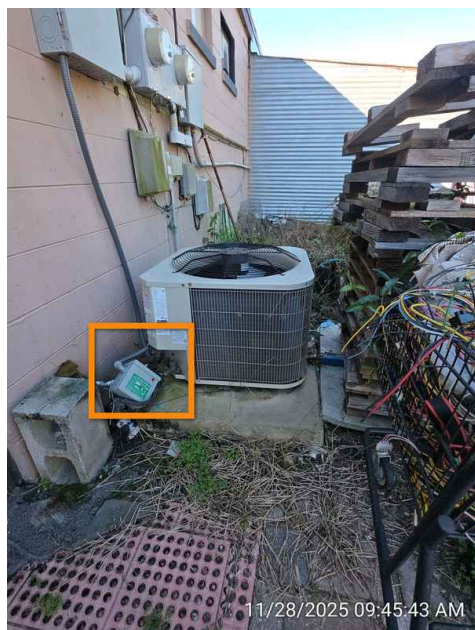
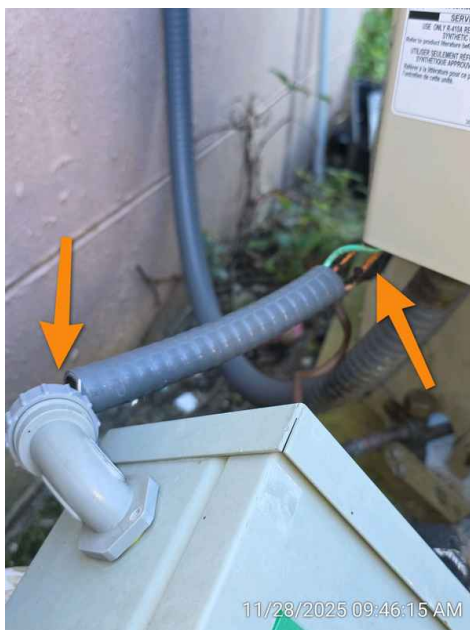
Conduit was displaced allowing wiring to be exposed. Repairs to the conduit is recommended to be performed by a licensed electrician to properly protect the wiring.

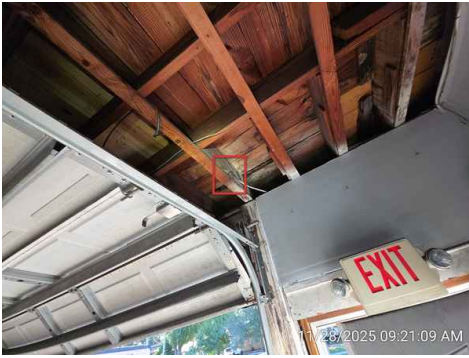
Unit 110

WIRING - EXPOSED TERMINATIONS PRESENT

There were exposed wiring terminations/exposed wire ends present at the referenced area(s). Any exposed wire termination (live or not) in the property is recommended to either be removed, or terminated into a junction box by a licensed electrician.

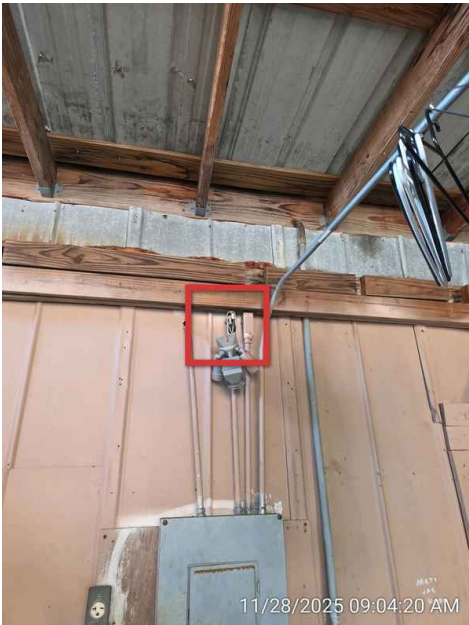
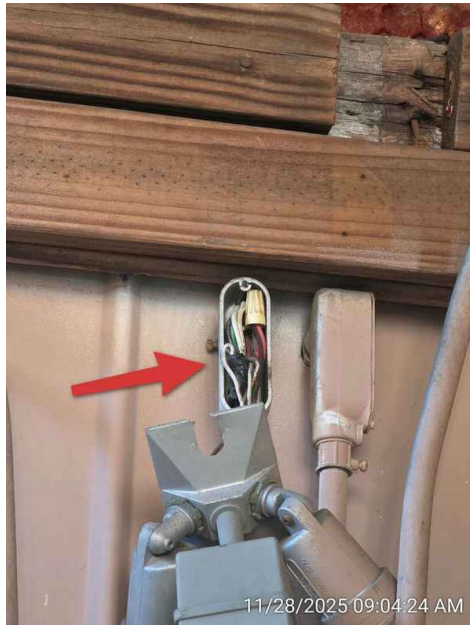
A wiring termination was present at the referenced area(s). Any wire terminations (live or not) should be removed or terminated into an electrical box for safety by licensed electrician.

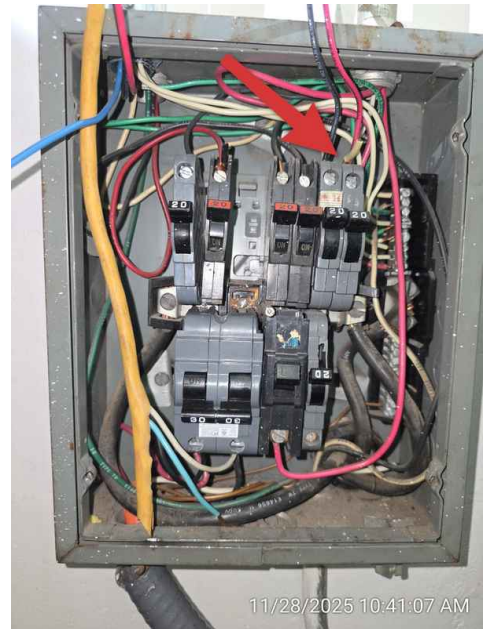
Unit 130

BREAKER(S) - DOUBLE TAPPED

Double-lugged breaker(s) were present in the panel. This is where two conductors (wires) are under the lug (screw) of a breaker. The breakers are only rated for one conductor, and the lug can not be torqued to proper specs with two wires present, which could cause overheating, arcing, or other deficiencies. Repairs are recommended to be performed here as deemed necessary by a licensed electrician.

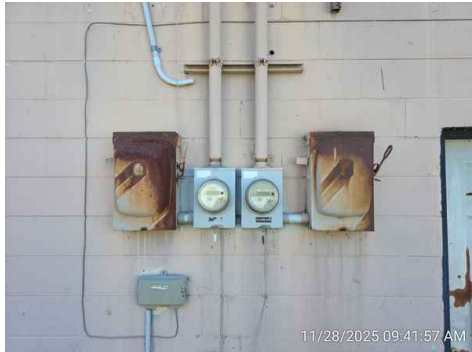
Units 120 & 122

Fused service panel(s) were observed in the referenced area(s). These older systems may not offer the same convenience or safety features as modern circuit breaker panels. Evaluation by a licensed electrical contractor is recommended if upgrades or modifications are planned.

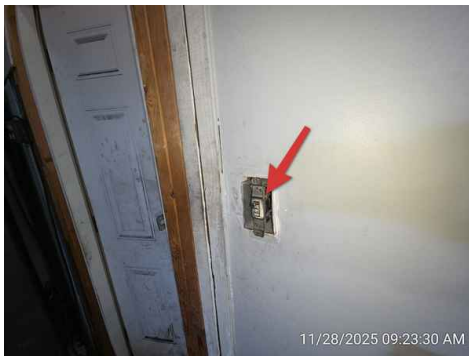
Unit 110

COVER PLATE(S) - MISSING

The were receptacles with missing cover plate(s) at the referenced area(s). This is a safety hazard, as someone could be shocked by touching live wires. The installation of new plates is recommended to be conducted by a qualified person on any and all plates that are missing throughout the property.

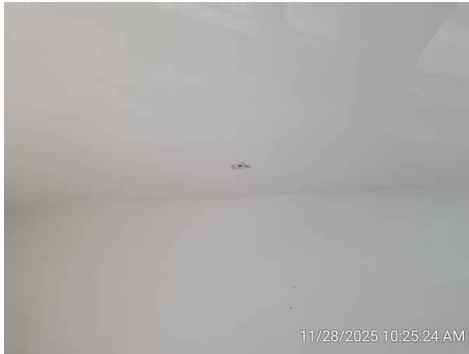
Unit 120

The light fixture at the referenced area was not installed at the time of inspection. The installation of a light fixture is recommended to be performed here by a licensed electrician.

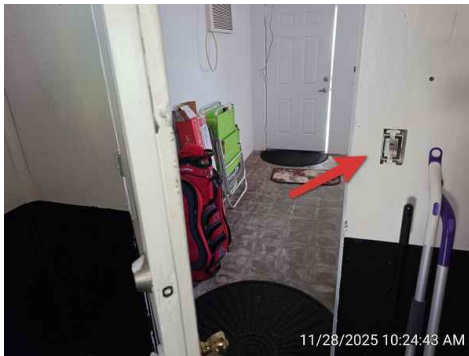
Unit 120

SWITCH(ES) - COVER PLATE(S) MISSING

There were missing switch cover plate(s) present at the referenced area(s). This exposes live wiring and is a potential shock hazard. The installation of cover plates is recommended to be conducted on any switches missing plates by a qualified person.

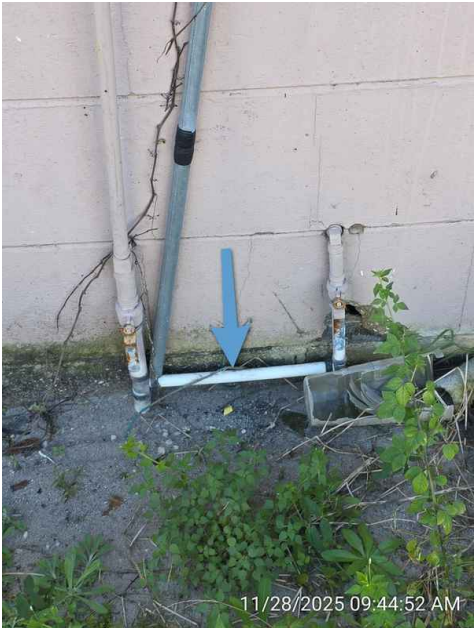
PEX water piping was observed to be exposed to ultraviolet (UV) light in the referenced area(s). Prolonged UV exposure can degrade the material, reducing its lifespan and performance. Recommend evaluation and protection or modification by a licensed plumbing contractor.

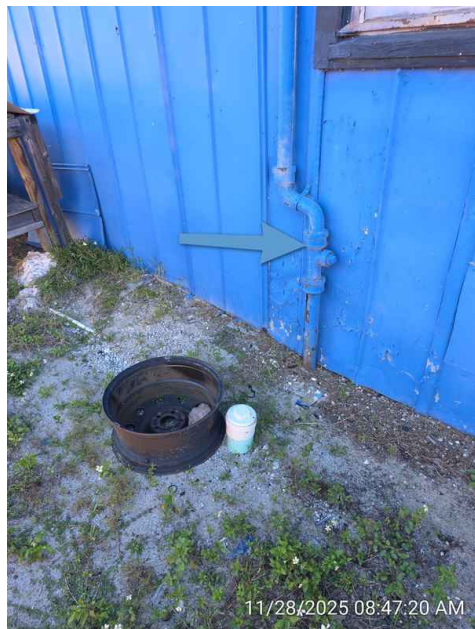
Bldg 1

CAST IRON - AGED WASTE AND DRAIN PIPES

AGED - Cast iron and/or galvanized drain, waste, and vent pipes were present. These pipes typically have a 50 - 60 year life and will eventually develop inner corrosion that will affect the draining functionality of the system, and cause failure. These pipes will need to be monitored for performance, with the understanding that major repairs or replacement will be needed at some point in the future due to their age. The remaining life is undeterminable. A sewer camera inspection of the pipes is highly recommended due to their age.

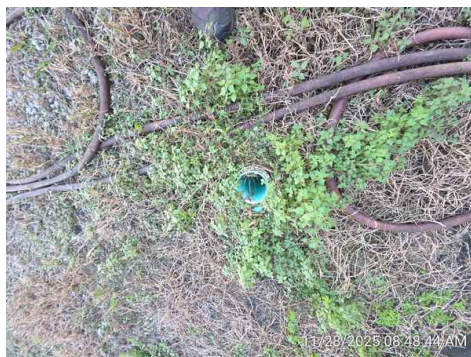
SEWER CLEANOUT DAMAGED

The sewer cleanout was observed to be damaged in the referenced area(s), which may hinder access for maintenance and allow debris or water intrusion. Recommend evaluation and repair by a licensed plumber.
