TIER-1 PRO INSPECTIONS

COMMERCIAL PROPERTY CONDITION ASSESSMENT

1234 Main Street
Winter Springs, FL 32708

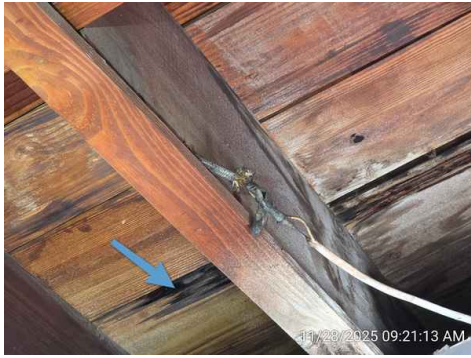
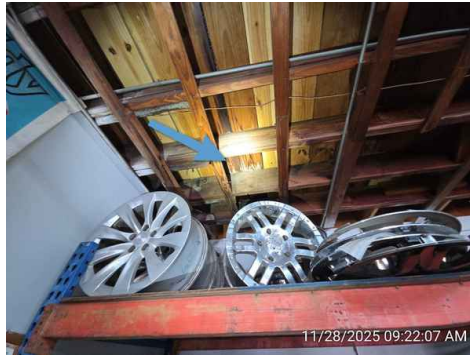
LEAKING - INDICATIONS OF PAST/PRESENT LEAKING PRESENT

Staining and/or damage consistent with past or present leaking was observed in the referenced area(s). The condition may indicate active moisture intrusion or previous water damage that was not properly repaired. Recommend evaluation and repair as needed by a licensed roofing contractor.

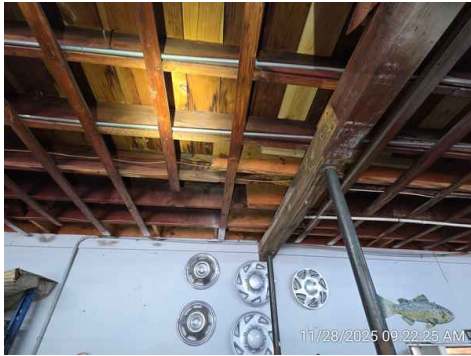
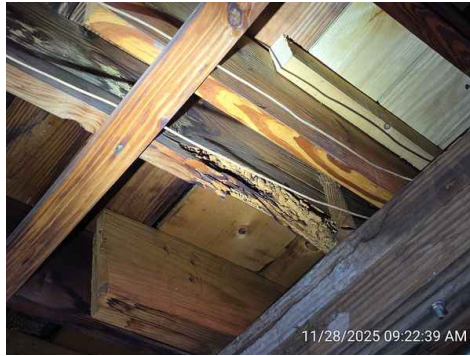
ROOF STRUCTURE - MOISTURE DAMAGE PRESENT

Moisture damage was observed in the roof structure in the referenced area(s), which may indicate past or active leaks and can lead to wood deterioration, mold growth, or compromised structural integrity. Depending on the extent of the damage, repairs may involve significant costs. Recommend evaluation and repair by a licensed roofing or general contractor.

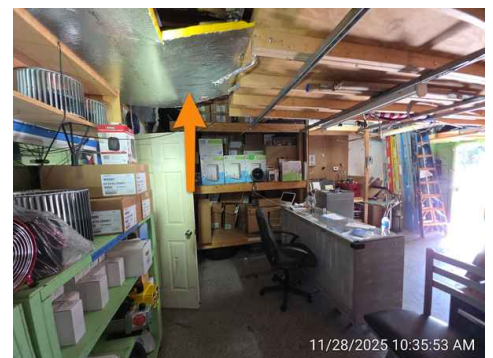
INSULATION - TYPICAL FOR AGE (MORE RECOMMENDED)

The insulation level was typical for when the property was built, but current energy star standards recommend approximately 14 inches of insulation to achieve an R-38 rating. The installation of additional insulation as an upgrade is recommended for comfort and energy efficiency by an insulation contractor.

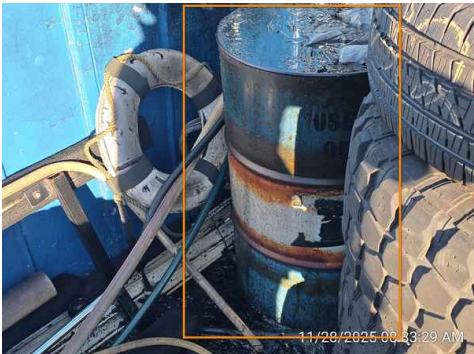
COMBUSTIBLE MATERIAL(S) - NOT PROPERLY STORED

Combustible material, including used motor oil, was observed stored improperly in the referenced area(s), without approved containment or separation from ignition sources. This condition may pose a fire hazard and violate standard safety practices. Recommend evaluation and correction by a licensed contractor or qualified facility safety professional.

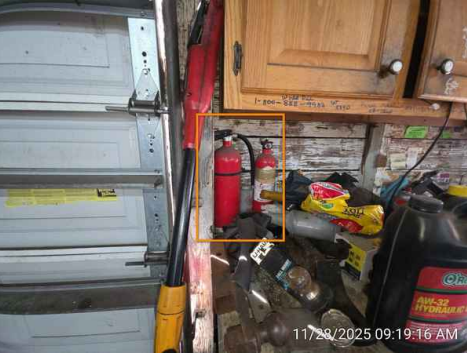
Unit 110

FIRE EXTINGUISHER(S) - NOT SERVICED WITHIN 12 MONTHS

The referenced portable fire extinguisher(s) do not display evidence of servicing within the past 12 months, as required for proper functionality. Regular servicing ensures extinguishers are in working condition during emergencies. Recommend evaluation and servicing by a licensed fire protection contractor.

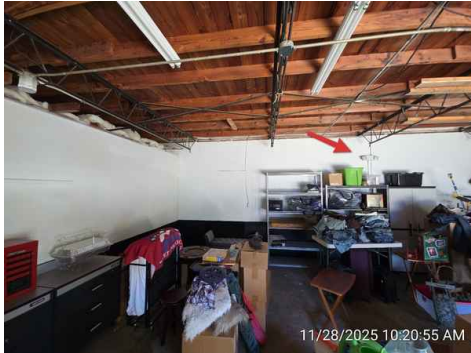
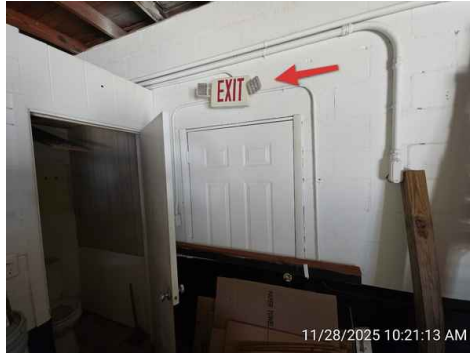
The emergency lighting system was observed to be non-functional or in need of servicing in the referenced area(s). This condition may affect visibility and safe egress during power outages or emergencies. Recommend evaluation and servicing by a licensed electrical contractor or life safety systems professional.

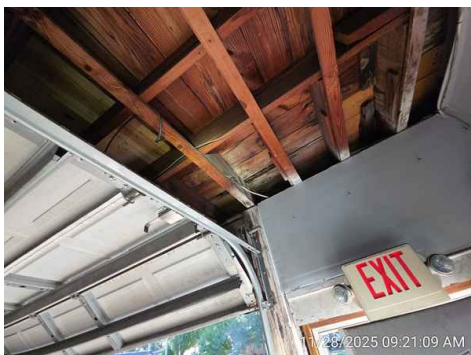
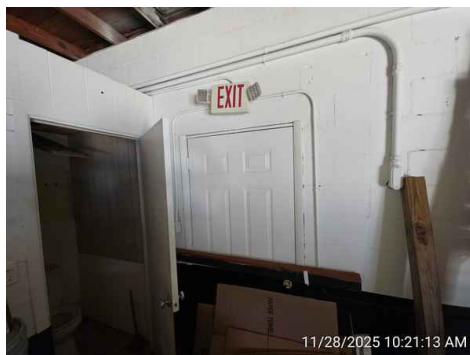
Several lighted emergency exit signs were not functional in the referenced area(s). Recommend servicing these exit signs to ensure adequate visibility in the event of a fire.

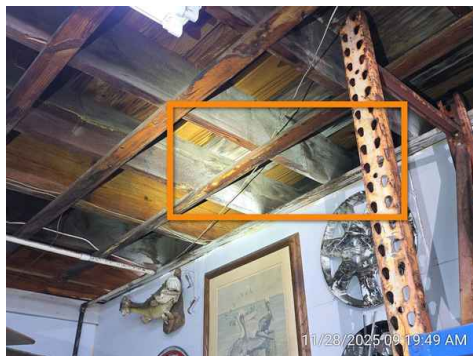
Fungal growth was observed on the referenced surface(s). This condition can contribute to poor indoor air quality and potential health concerns. It may indicate underlying moisture issues that need addressing to prevent further growth. Recommend cleaning and remediation by a licensed mold remediation contractor.

- Perform moisture mitigation and remediate fungal growth on affected interior surfaces: \$1,200-\$2,500
- Total Short-Term Costs: \$1,200 - \$2,500**
